NIOSH
Fire Fighter Fatality Investigation
and Prevention Program

September 23, 2005

One Part-time Fire Fighter Dies and Another Is Seriously Injured When Two Fire Engines Collide at an Intersection While Responding to a Fire - Illinois

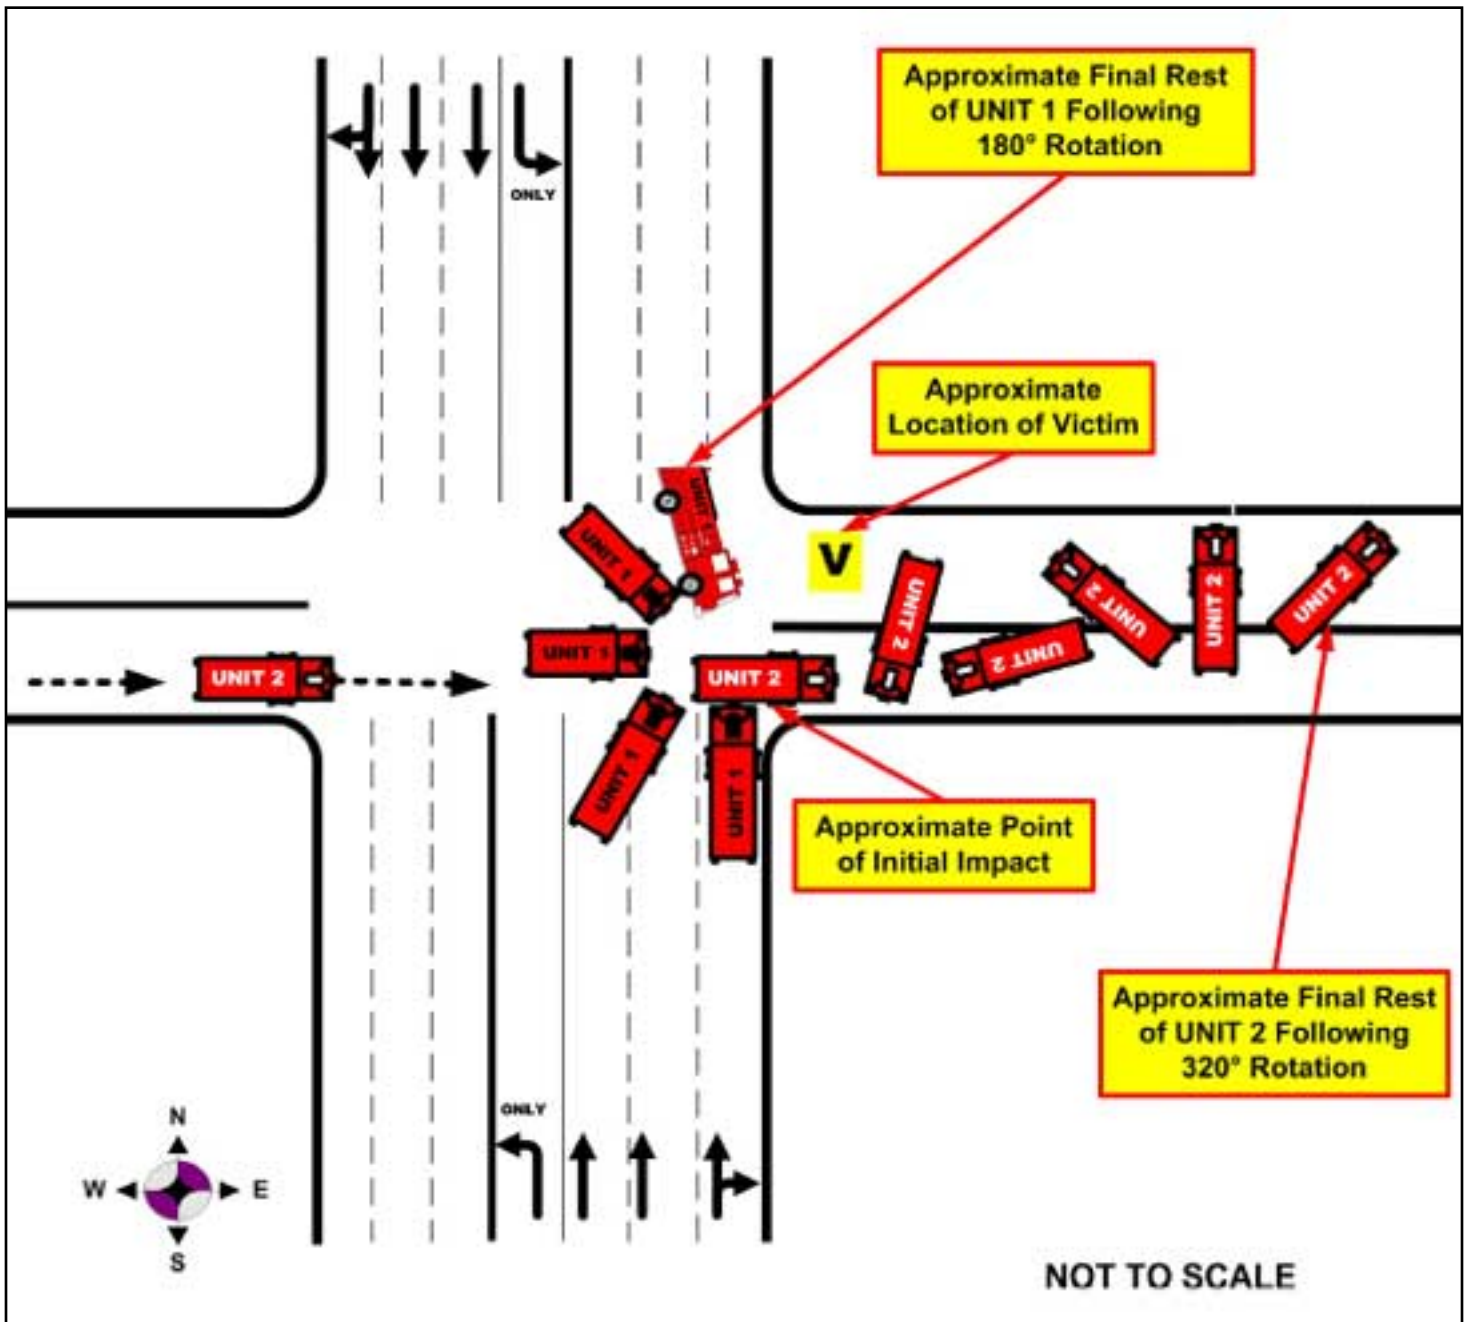
Weather/road: The incident occurred at the intersection of two concrete roadways bordered on both sides by raised concrete curbs. The east-west roadway (R1) has two lanes; the north-south roadway (R2) has three northbound and three southbound lanes. ([Diagram](#)). R2 has dedicated left-turn-only lanes on both the north- and southbound sides. Traffic at the time of the crash was reported as being of medium density. The crash occurred during daylight hours; the weather was clear and the roads were dry.

Diagram. Aerial view of intersection where crash occurred

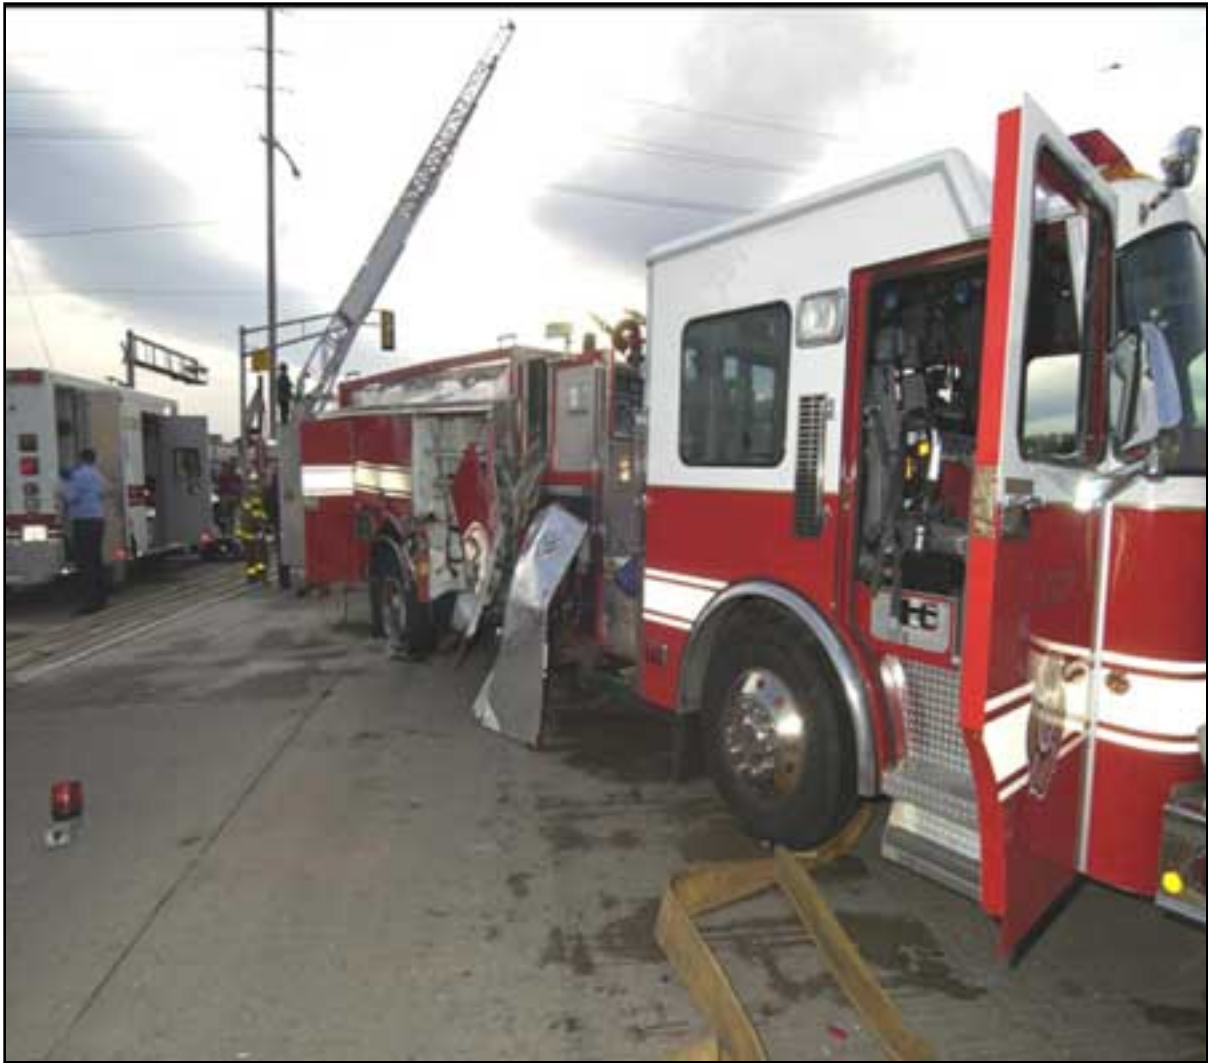
Photo 1. View of Unit 2 which was struck on the passenger side

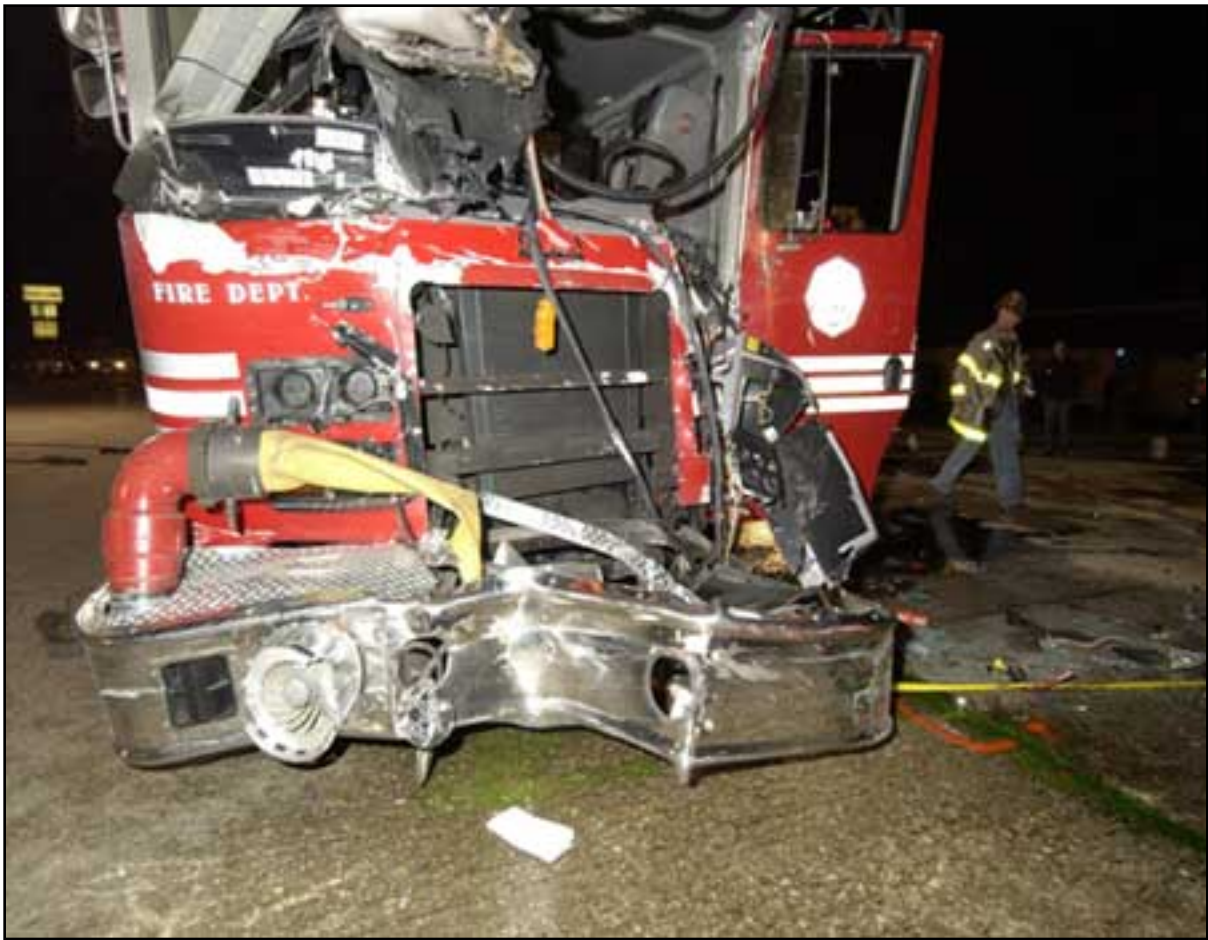
Photo 2. Crushed front end of Unit 1
