# Final Report

**Southwest Supermarket Fire  
35th Avenue and  
McDowell Road**

**March 14, 2001  
Incident #01-045301**

**Phoenix Fire Department  
150 South 12 Street  
Phoenix, Arizona 85034**

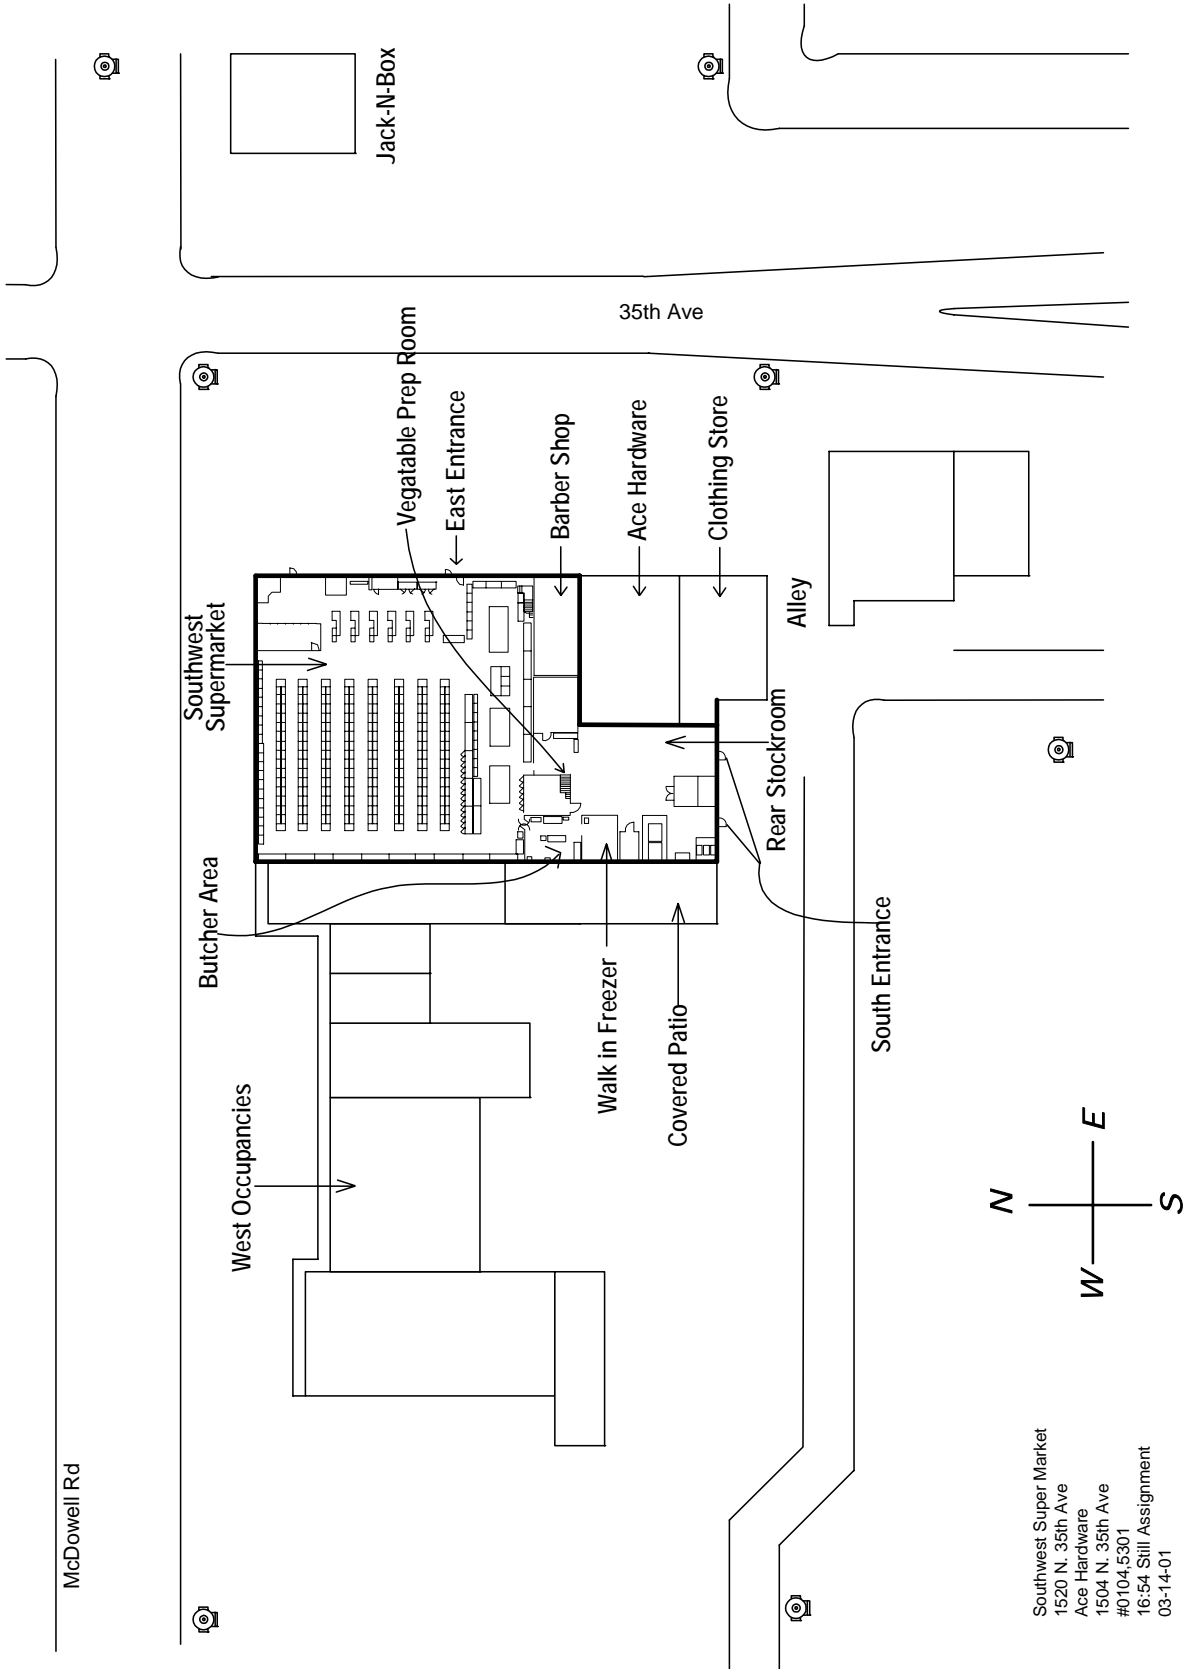
The building was constructed upon a “pad” of concrete with no sub-levels. The walls were constructed of 12” x 4” x 16” concrete cinder block (un-reinforced CMU’s). Horizontal shear reinforcement was found at approximately every 24 inches on center. The structural framework for the roof assemblies consisted of steel columns and beams with open web steel truss. The beams in the store area were setting in beam pockets. Holding the beams were 6” pipe columns. The trusses were placed 6 feet apart, with purlins spanned across from truss to truss to support the roofing materials. On the east side of the supermarket there was an approximate 12’ cantilever that covered the front entrance. In the rear storage area there were no beams, only trusses spanning from east to west.

On the south side, in the alleyway, was a power pole approximately 20 feet away from the rear entrance. There was a bank of three transformers with an electrical drop that fed the entire complex. The electrical wires entered above the rear loading dock and were directly above the initial fire location.

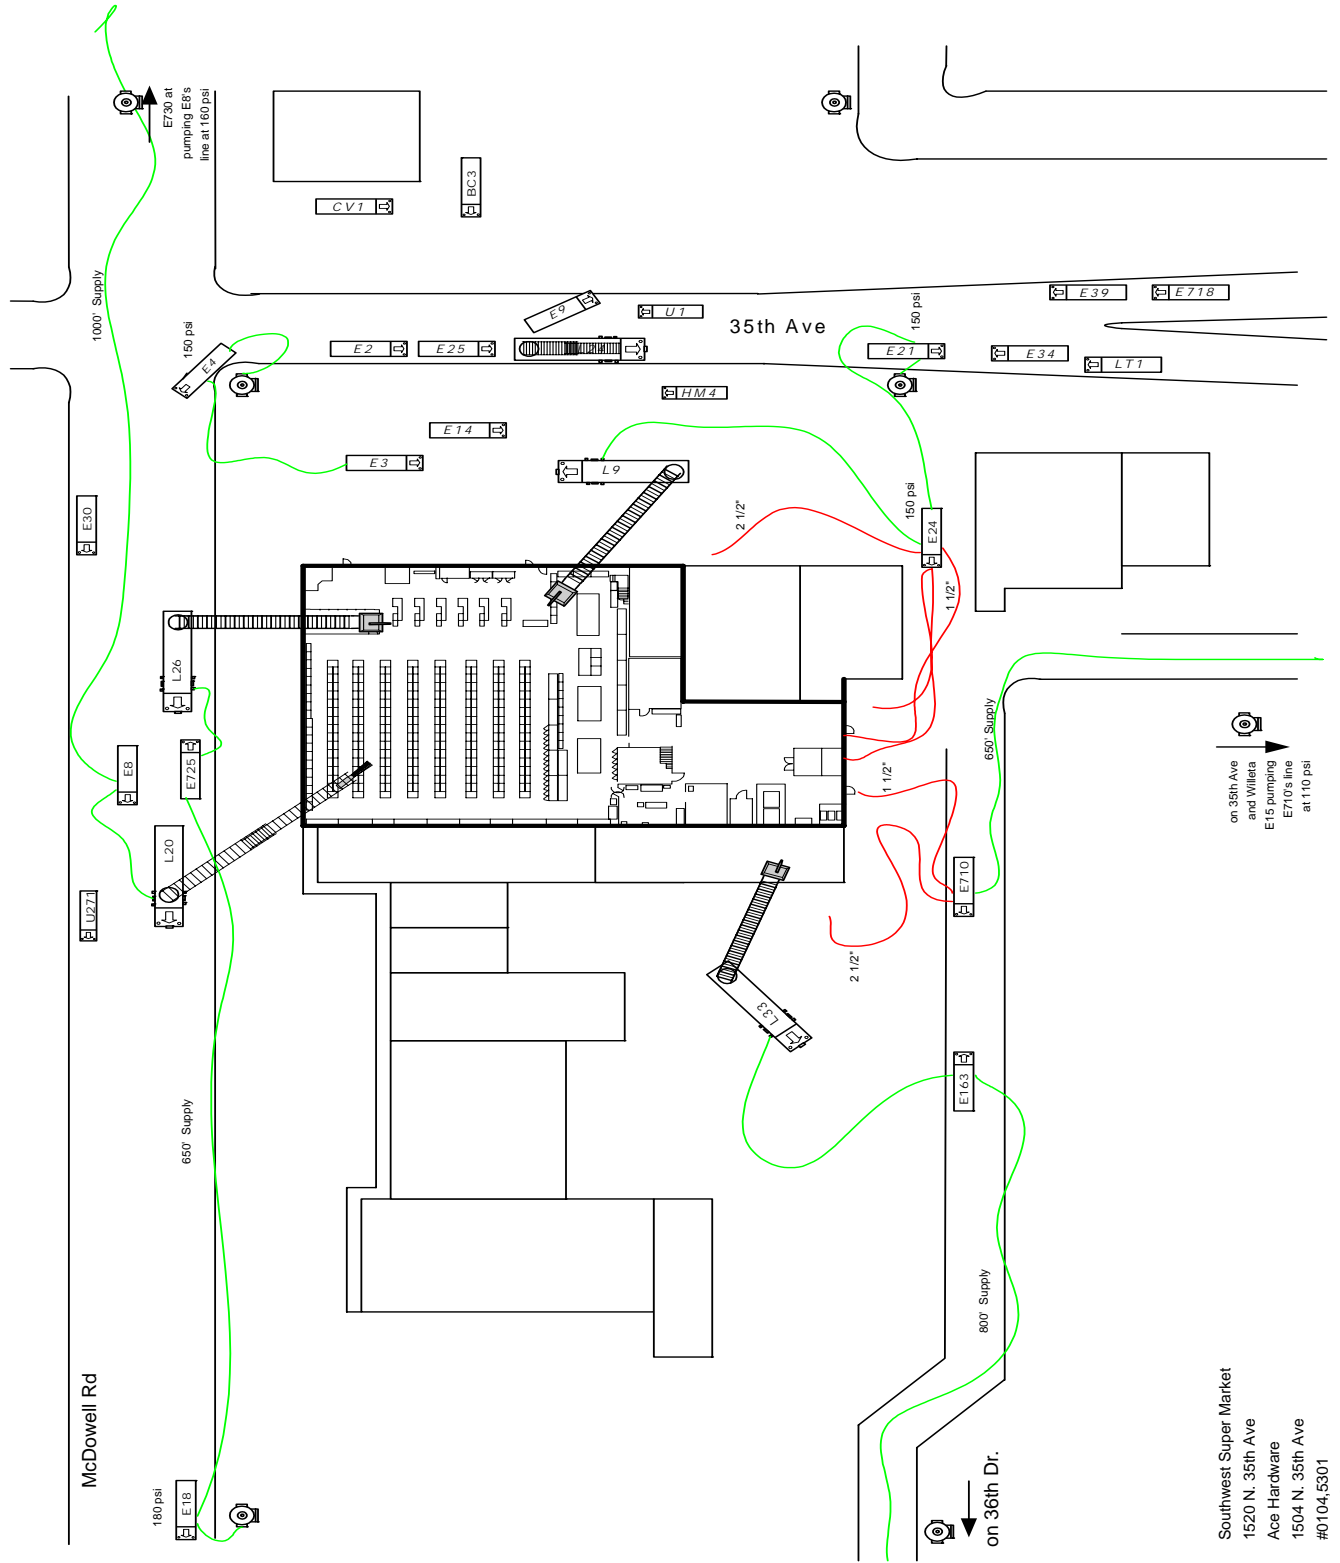
# Apparatus Placement / Defensive Operation

Southwest Super Market  
 1520 N. 35th Ave  
 Ace Hardware  
 1504 N. 35th Ave  
 #0104.5301  
 16:54 Still Assignment  
 03-14-01

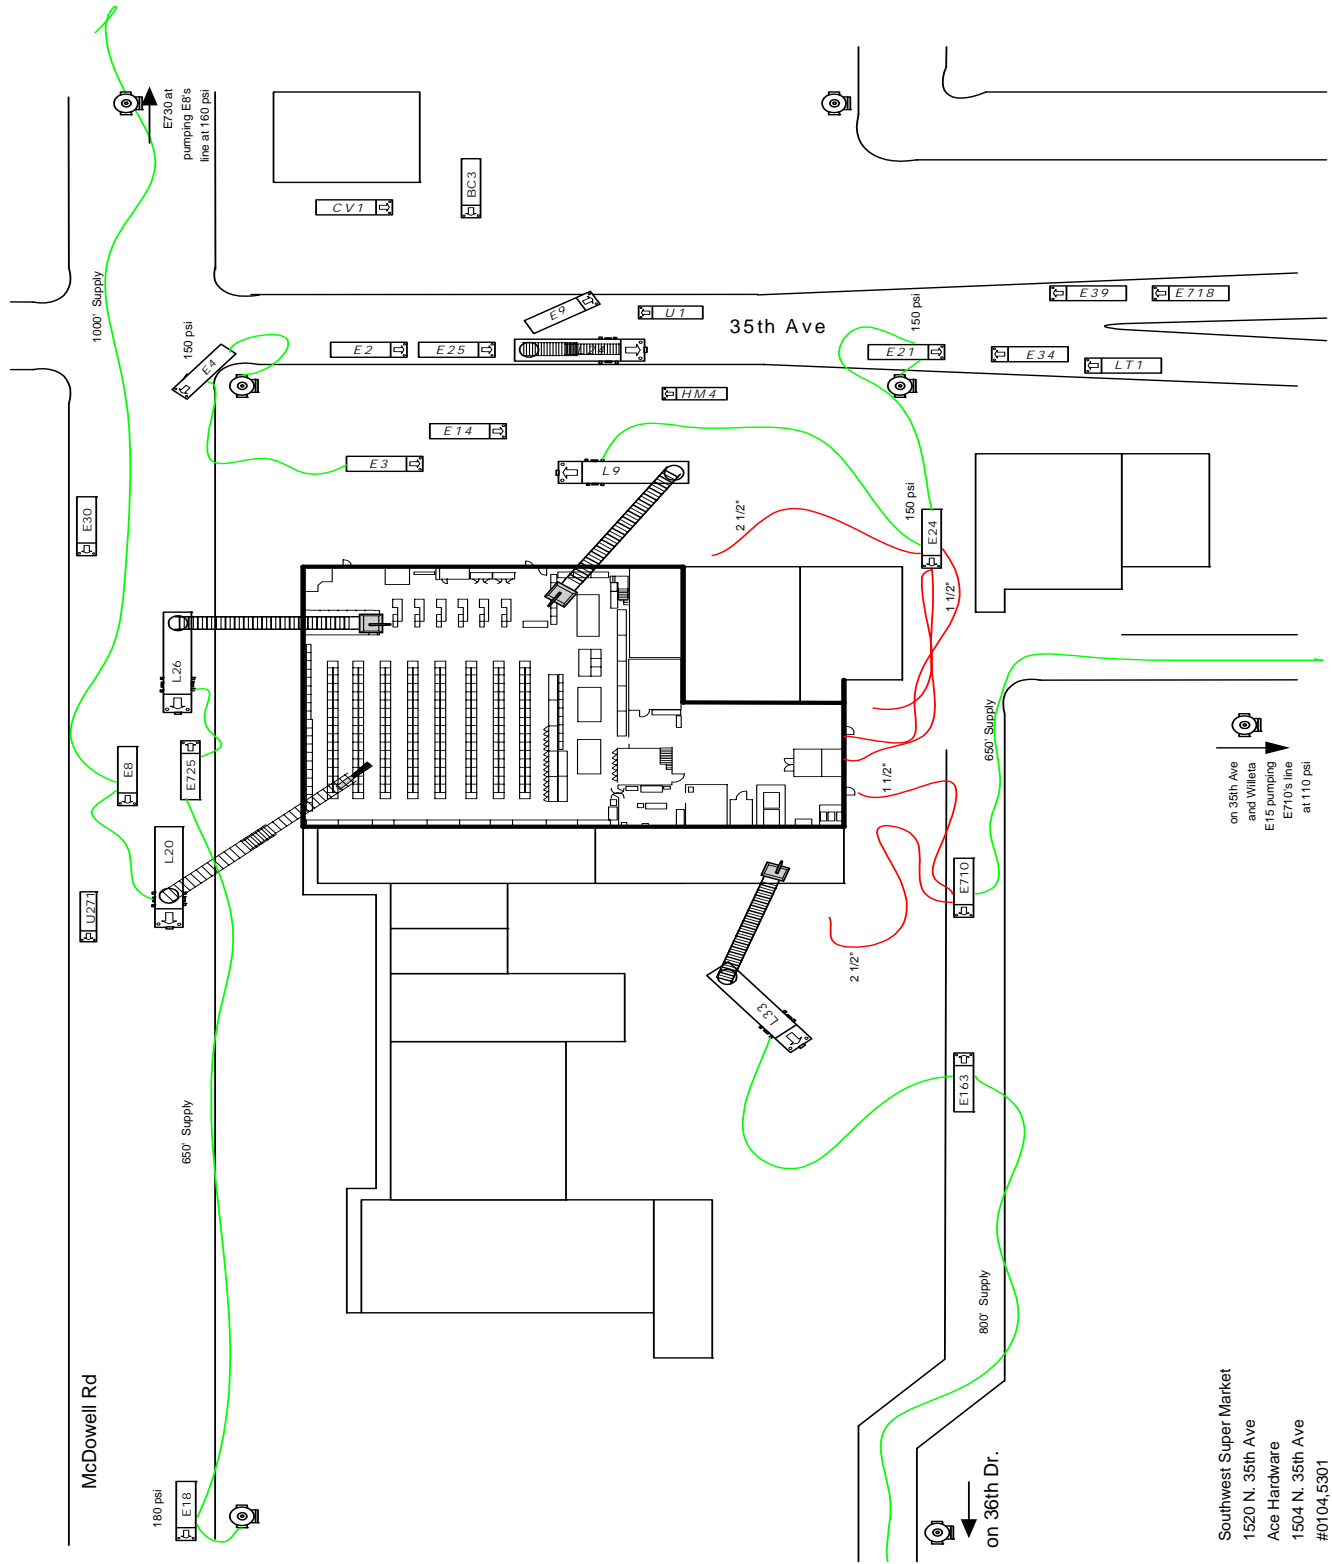
on 35th Ave  
 and Willela  
 E15 pumping  
 E710's line  
 at 110 psi
