NIOSH
Fire Fighter Fatality Investigation
and Prevention Program

A summary of a NIOSH fire fighter fatality investigation

December 30, 1999

One Fire Fighter Died and a Second Fire Fighter Was Severely Injured After Being Struck by a Motor Vehicle on an Interstate Highway-Oklahoma

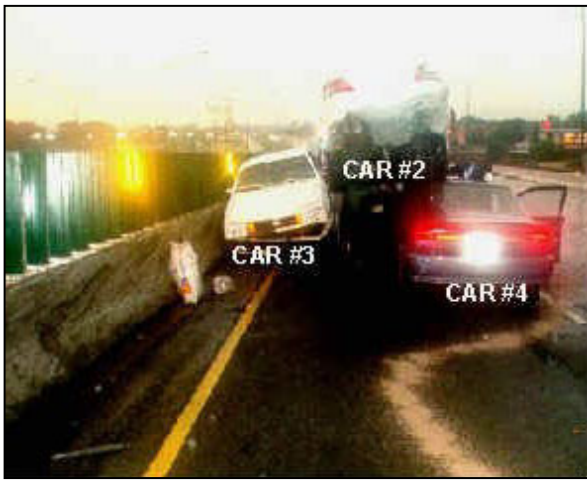
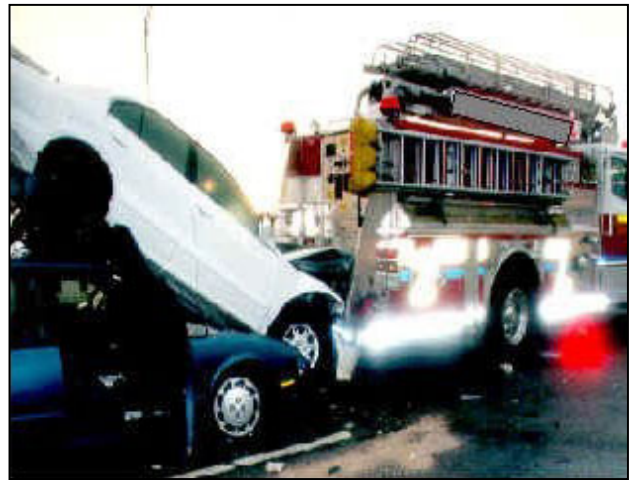
Photo 1 - Incident Scene

(Ladder 2) accompanied by a squad vehicle (Squad 2) were dispatched to a single motor vehicle crash on an interstate. Approximately 2-3 minutes after arriving on the scene, a car (car #2) collided into the back of Ladder 2. While attending to the injuries of the driver from car #2, a fire fighter from Ladder 2, the victim from Squad 2, and the civilian driver of car #2 were struck by car #3 that had struck the median wall, wedging itself between the wall and the Ladder truck (See Diagram 1 and Photo 1).

View from back of scene

View of scene from side

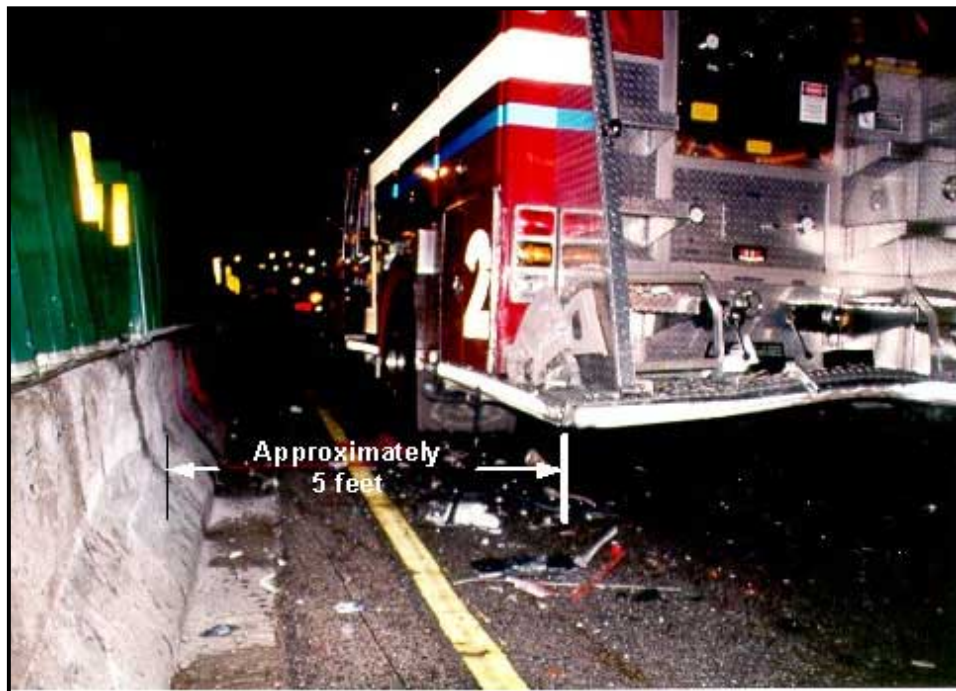
Photo 2 - Ladder 2 after vehicles were removed.

Note - Distance between median wall and Ladder 2 where car #3 was located is approximately 5 feet wide.

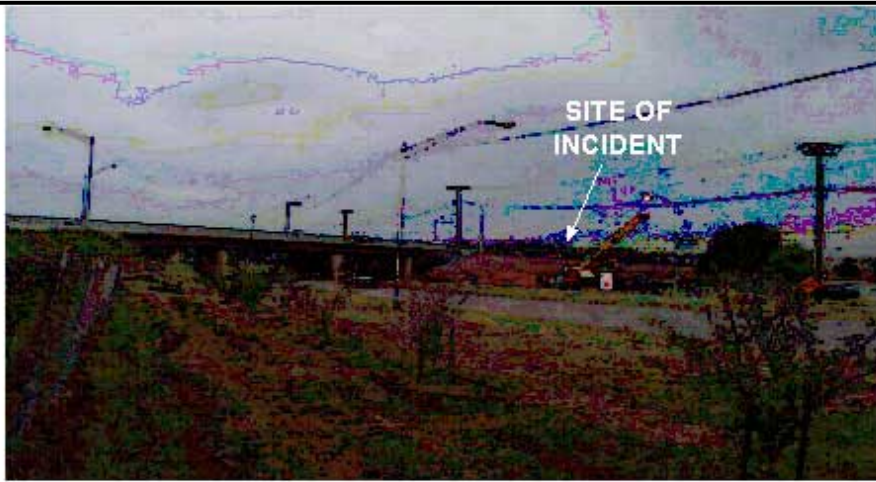
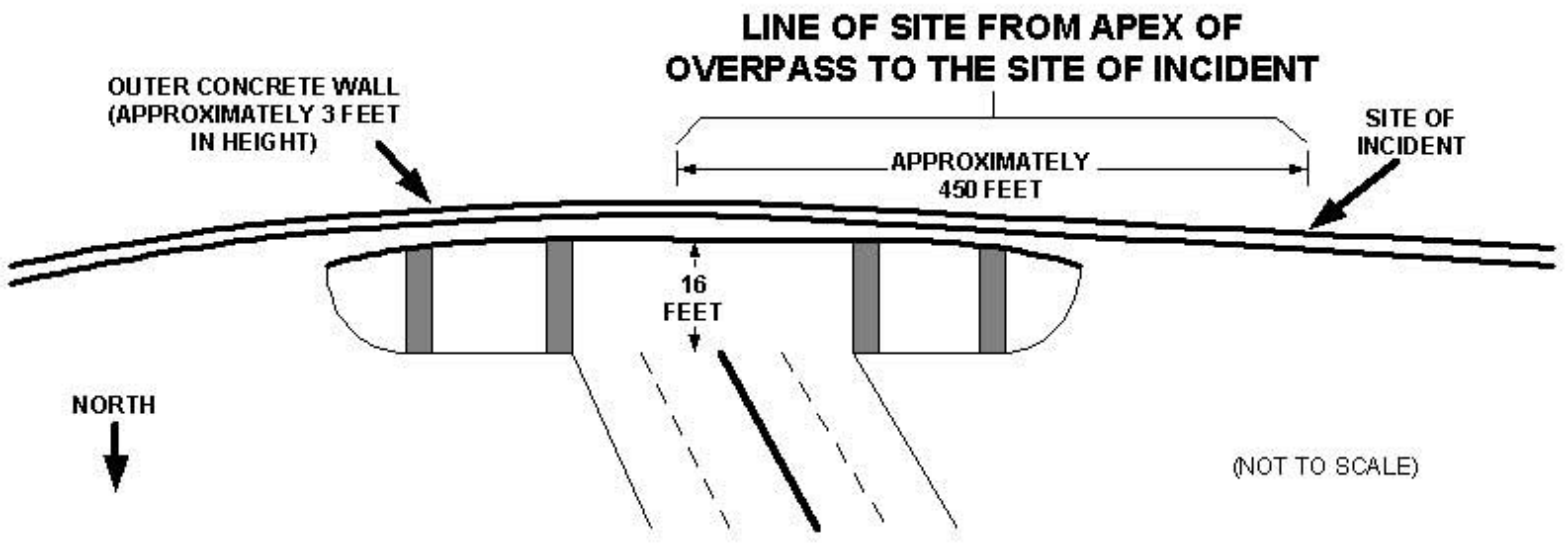
DIAGRAM 2 - PROFILE OF HIGHWAY OVERPASS WHERE INCIDENT OCCURRED

PROFILE PHOTO OF OVERPASS WHERE INCIDENT OCCURRED
