NIOSH
Fire Fighter Fatality Investigation
and Prevention Program

May 9, 2005

Career Fire Fighter Dies From Injuries Sustained In Fall From Apparatus - Massachusetts

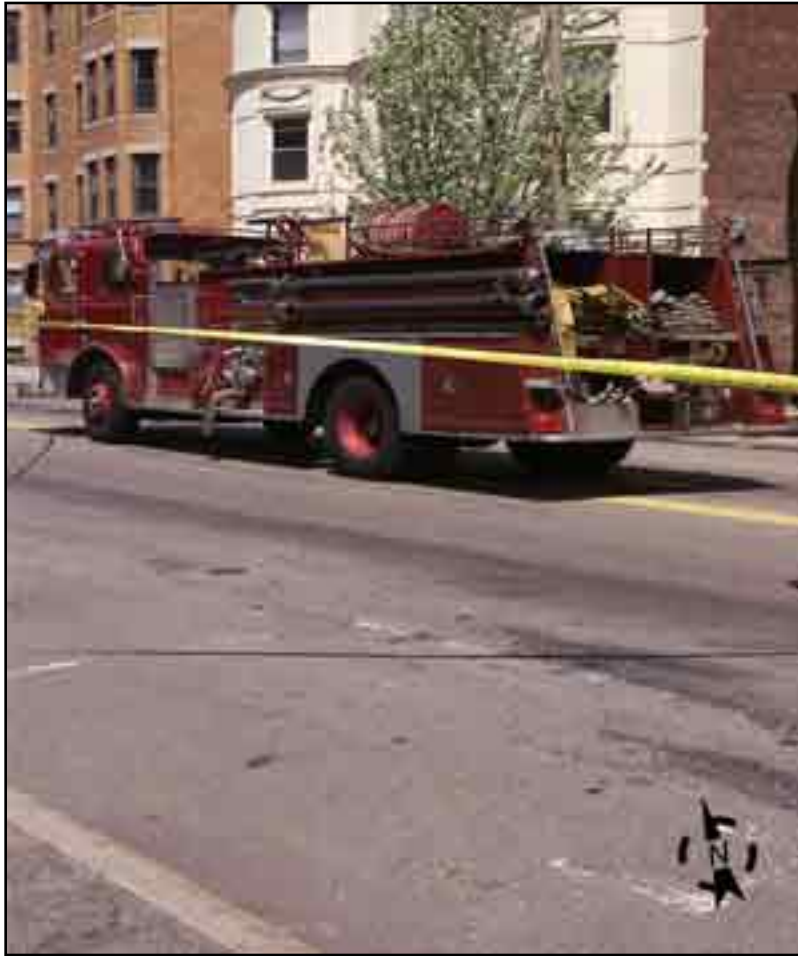
Incident scene

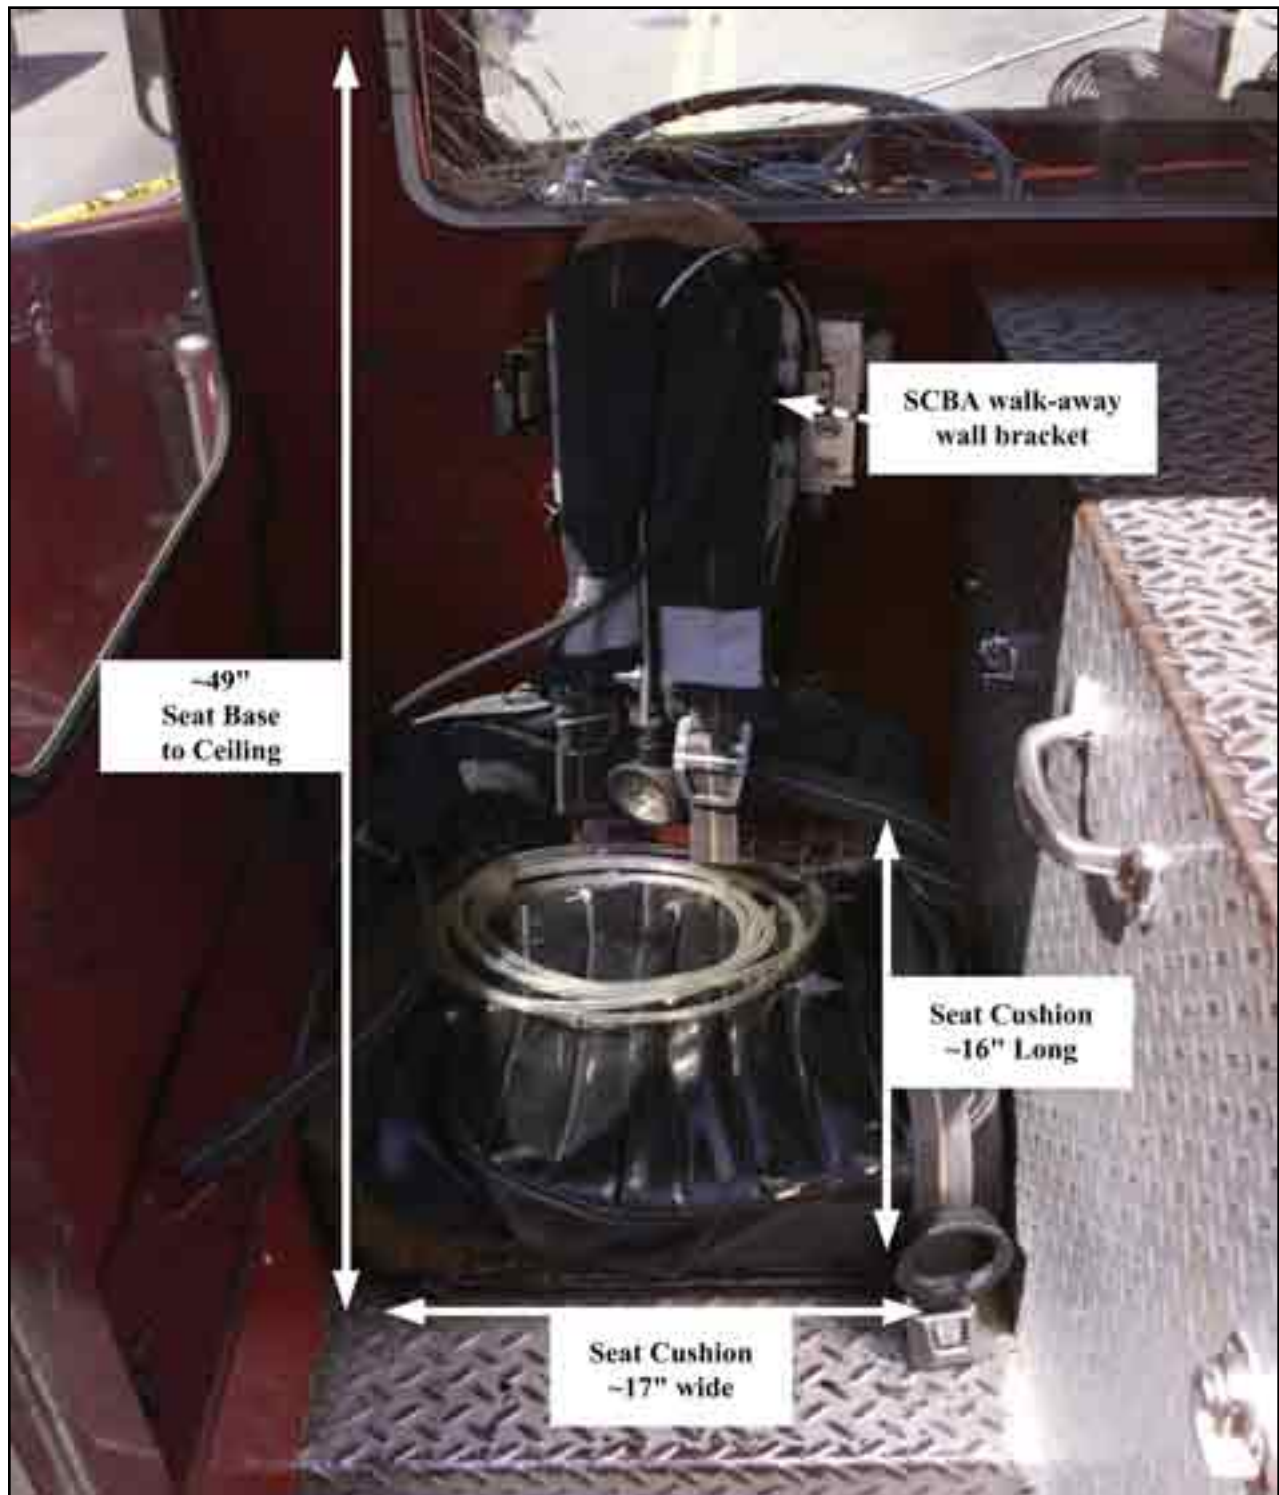
Photo 1. Victim's seating position

Equipment The victim was riding in a 1976 cab-forward engine that was being used as a reserve unit while the assigned engine was in the shop for maintenance. The fire department purchased the engine new in 1976 and had safety bars installed in the open jump seat area. In 2001, the safety bars were replaced with half-style doors that were equipped with a slam-lock system. The door locking system included an inside vertical and thumb-rotary locking/unlocking feature. The seatbelt was a lap-only type. A self-contained breathing apparatus (SCBA) walk-away wall bracket^a was installed behind the victim’s seat ([Photo 1](#)).

During the police investigation immediately following the incident, the victim’s seat belt was found wedged under the seat cushion, indicating that the belt was not being worn.

Maintenance checks should include an inspection of all seat belts and safety restraints to ensure they are securely mounted and operate freely. Webbing must not be cut or frayed and buckles must open and close properly. The location of the seat belts or safety restraints should confirm that they are positioned to be worn. A check of the apparatus following the incident found the victim’s seat belt lodged beneath the bottom seat cushion.^{1, 5}

Recommendation #1: Fire departments should ensure that all persons responding in emergency apparatus are secured by seat belts, or safety restraints, at all times the vehicle is in motion.

Recommendation #2: Fire departments should ensure that routine apparatus maintenance includes documented inspections of all seating areas.

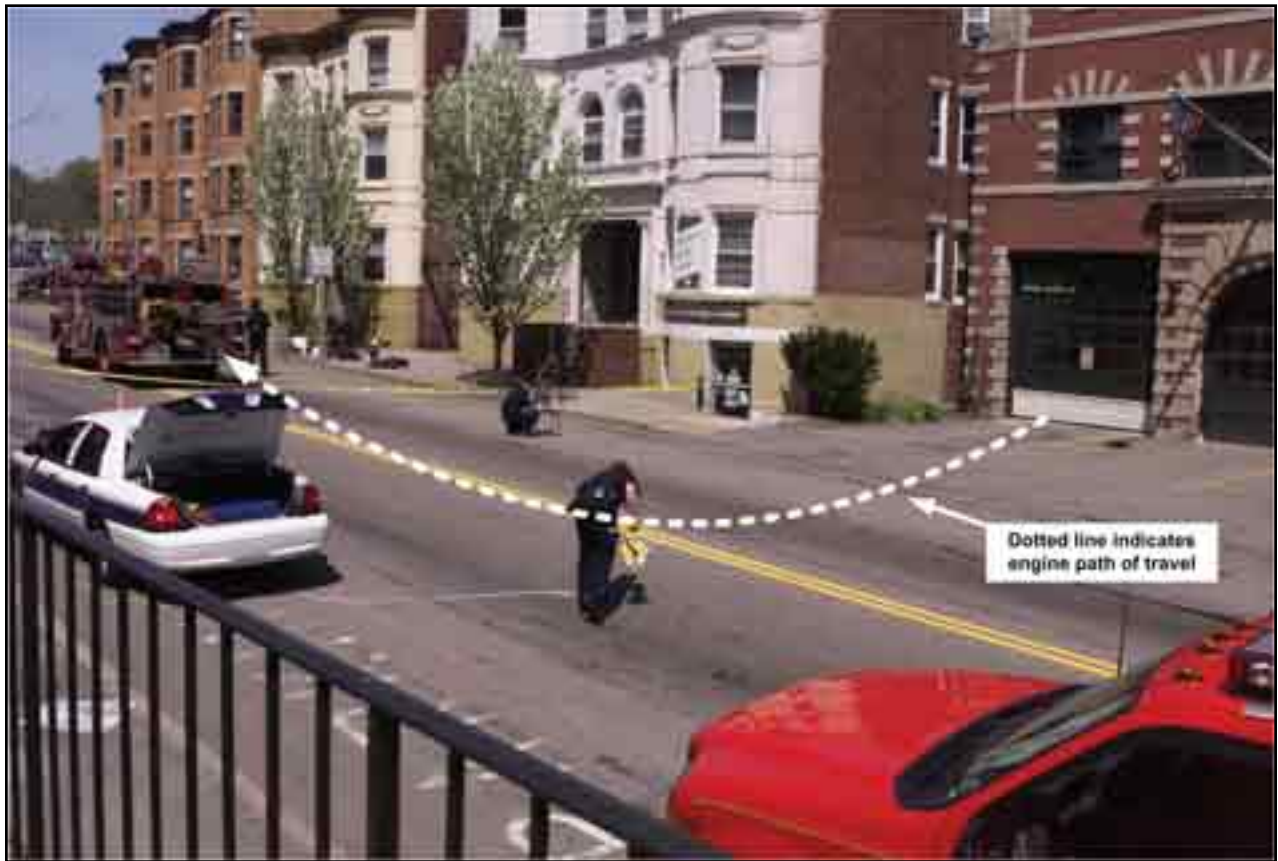
Photo 2. Engine path of travel

Weather / Road Conditions The incident occurred on a city street that runs directly in front of the fire station ([Photo 2](#)). The road surface is made of asphalt and is well traveled. There were no defects to the road surface that would hinder the performance of the roadway or interfere with the operation of the engine.

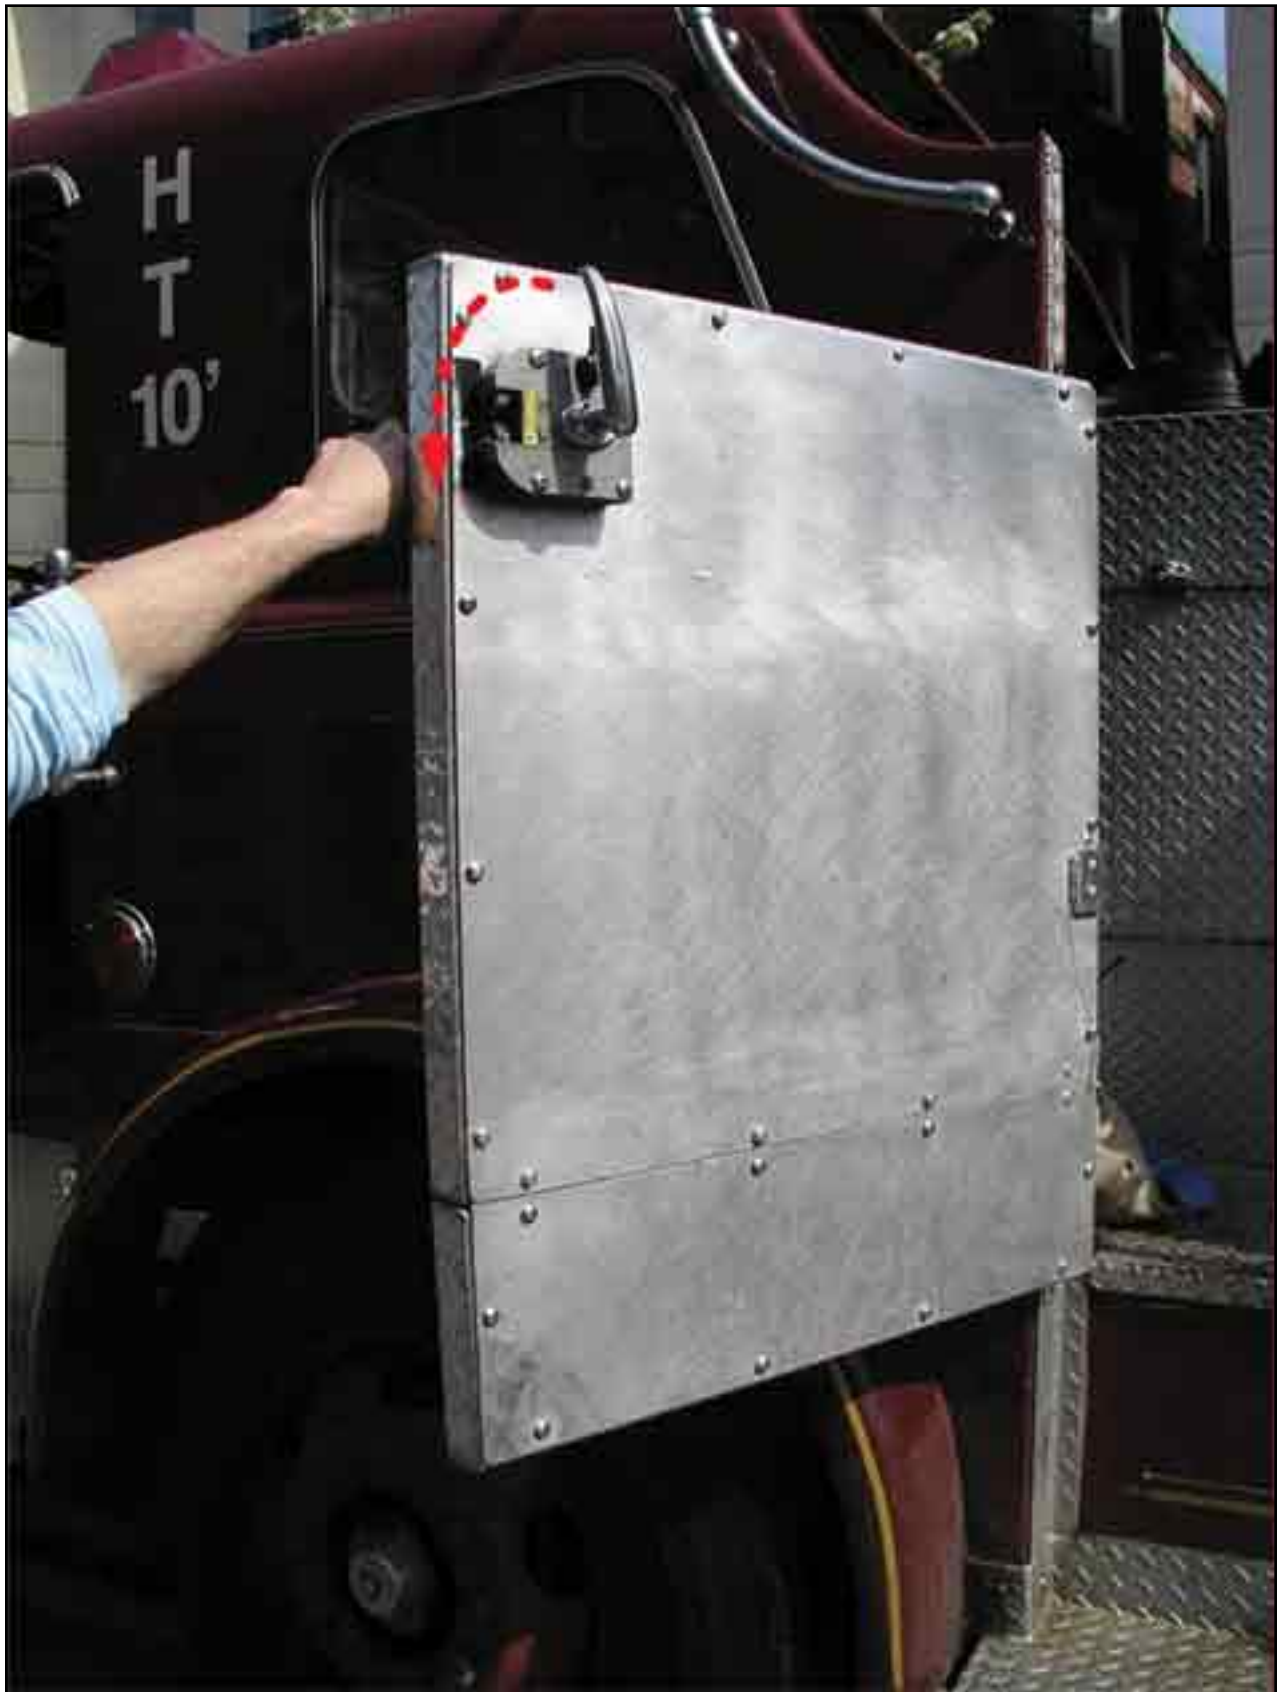
Photo 3. Depiction of door handle operation

The engine involved in this incident was a 1976 cab-forward model and was used as a spare during maintenance operations of assigned apparatus. At the time of the incident, the engine had been retrofitted with a half-door that was equipped with a slam-lock system. The door locking mechanism included an inside vertical and thumb-rotary locking/unlocking feature. Police determined that the door locking mechanisms were operational at the time of their investigation. When police officers closed and locked the door, the handle would not move under normal pressure and the door would not open. This indicated that the lock may not have been engaged at the time of the incident.

When at rest, the interior handle on the driver side jump seat door faces upward in a vertical position ([Photo 3](#)). Immediately following the incident, a police officer attempted to open the locked door by turning the handle and pushing his body forcefully against the door several times. These actions did not cause the door to open. The door could be opened only when it was unlocked and the handle was moved in a counterclockwise direction. These actions indicate that the door was not locked at the time of the incident.

Recommendation #4: Fire departments should ensure that all interior crew and driving compartment door handles are designed and installed to protect against inadvertent opening.

A recessed door handle, or one that is positioned to require intentional effort or deliberate motion to activate, would provide an extra safety measure that may prevent inadvertent opening.
