NIOSH
Fire Fighter Fatality Investigation
and Prevention Program

A summary of a NIOSH fire fighter fatality investigation

August 2, 2001

A Lieutenant Dies and Three Fire Fighters of a Career Department Were Injured When the Truck They Were Responding in Was Struck by Another Vehicle—Illinois

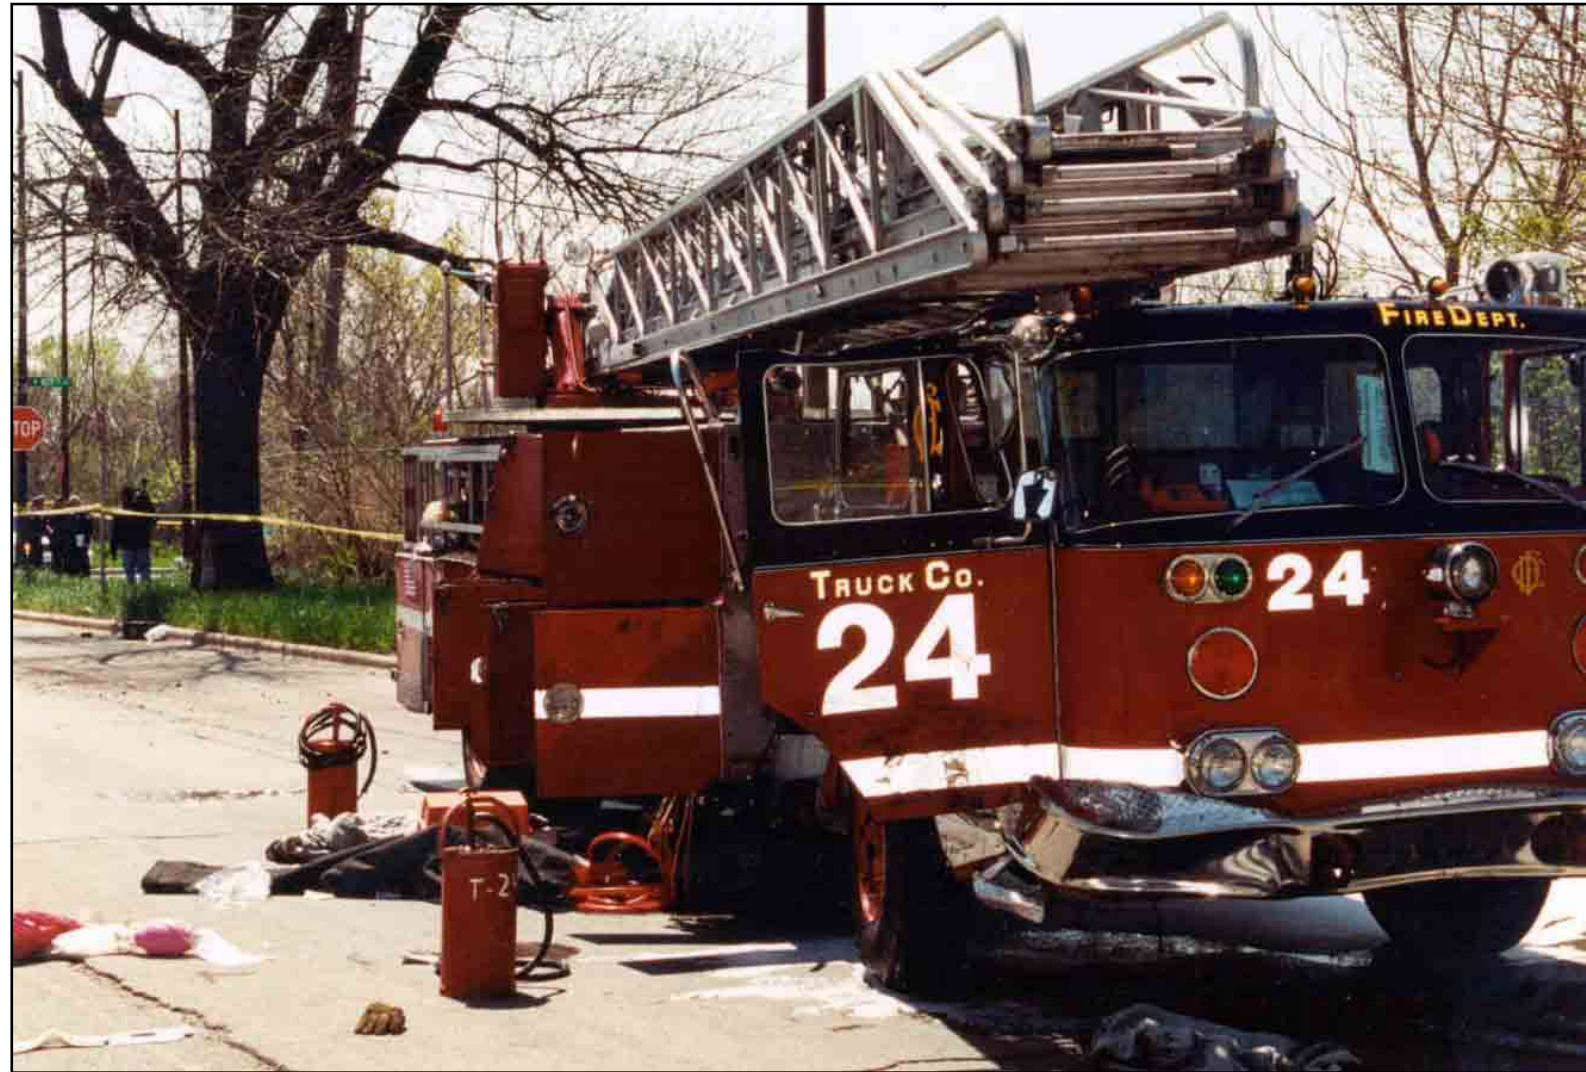
Apparatus Involved in This Incident

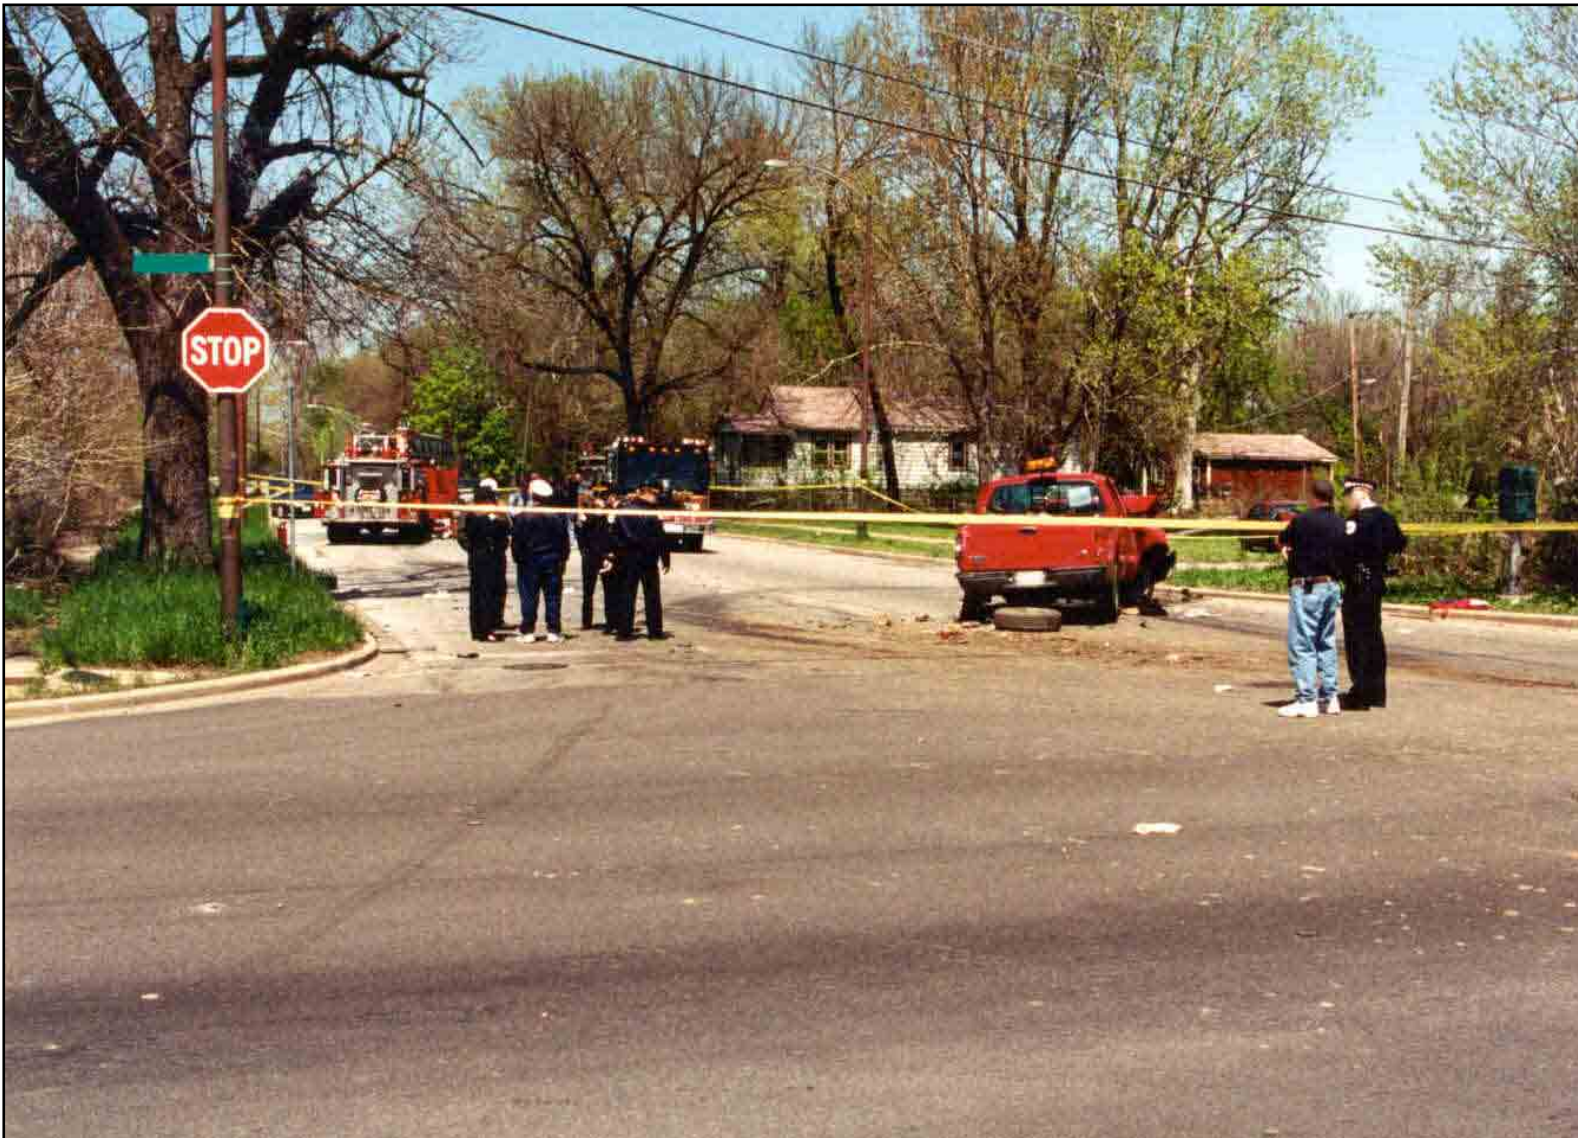
Photo. Final Resting Places of the Three Vehicles Involved in This Incident

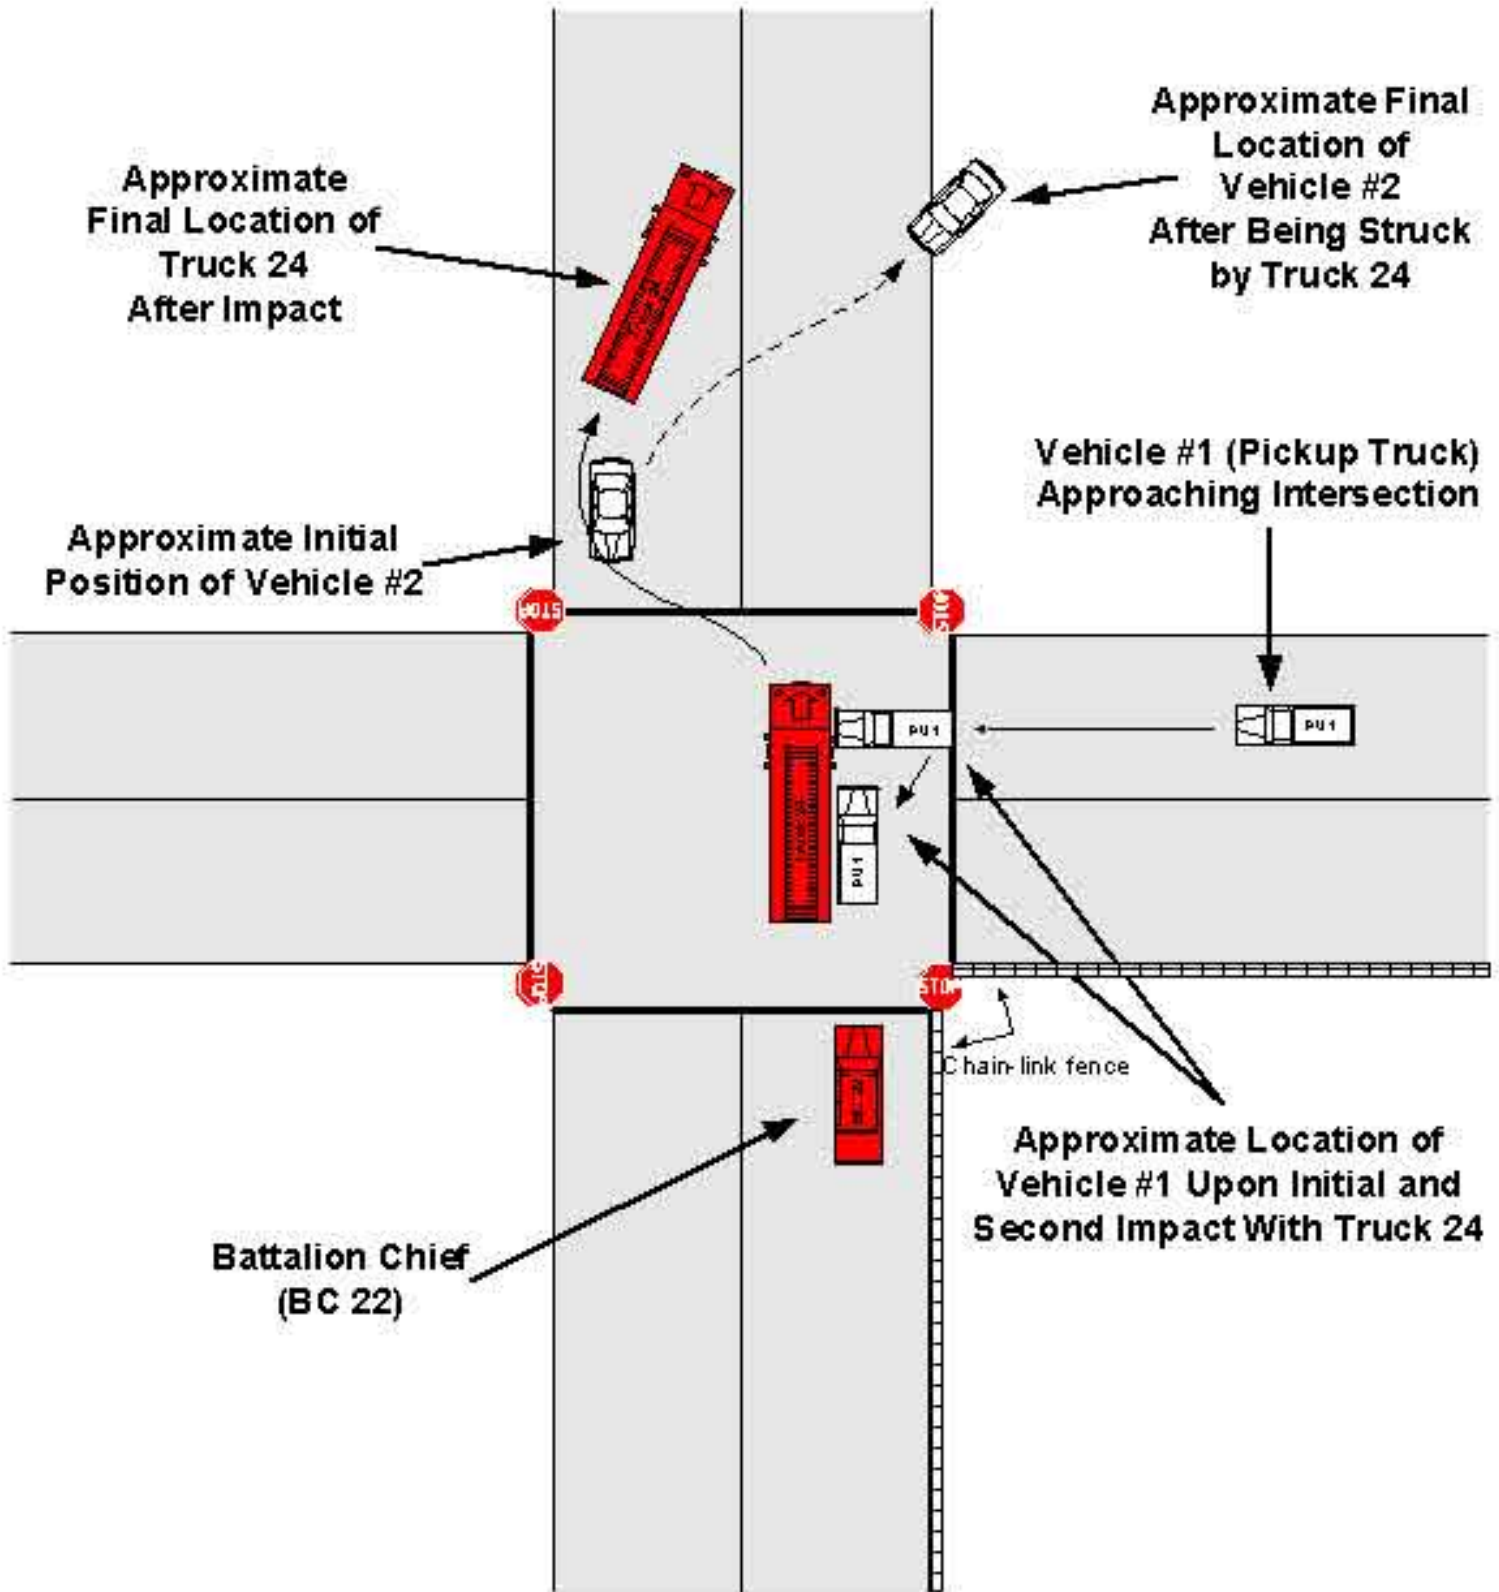
Diagram. Aerial View of Incident Site
