**NIOSH**  
Fire Fighter Fatality Investigation  
and Prevention Program

A summary of a NIOSH fire fighter fatality investigation

May 20, 2005

## Career Fire Fighter Dies After Falling From Tailboard and Being Backed Over by Engine - California

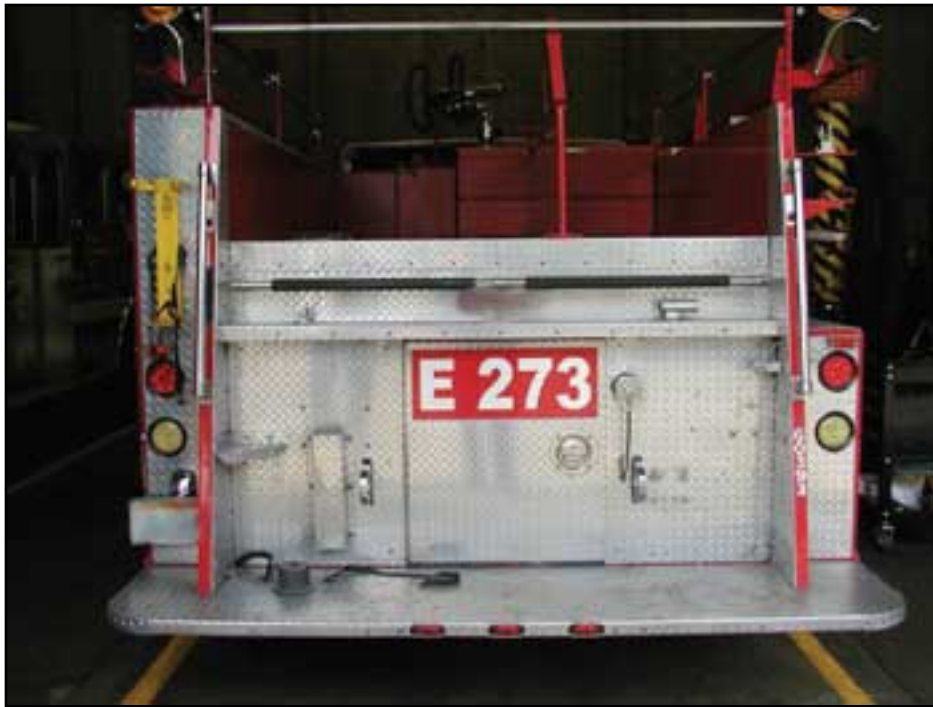
**Tailboard of Engine 273**

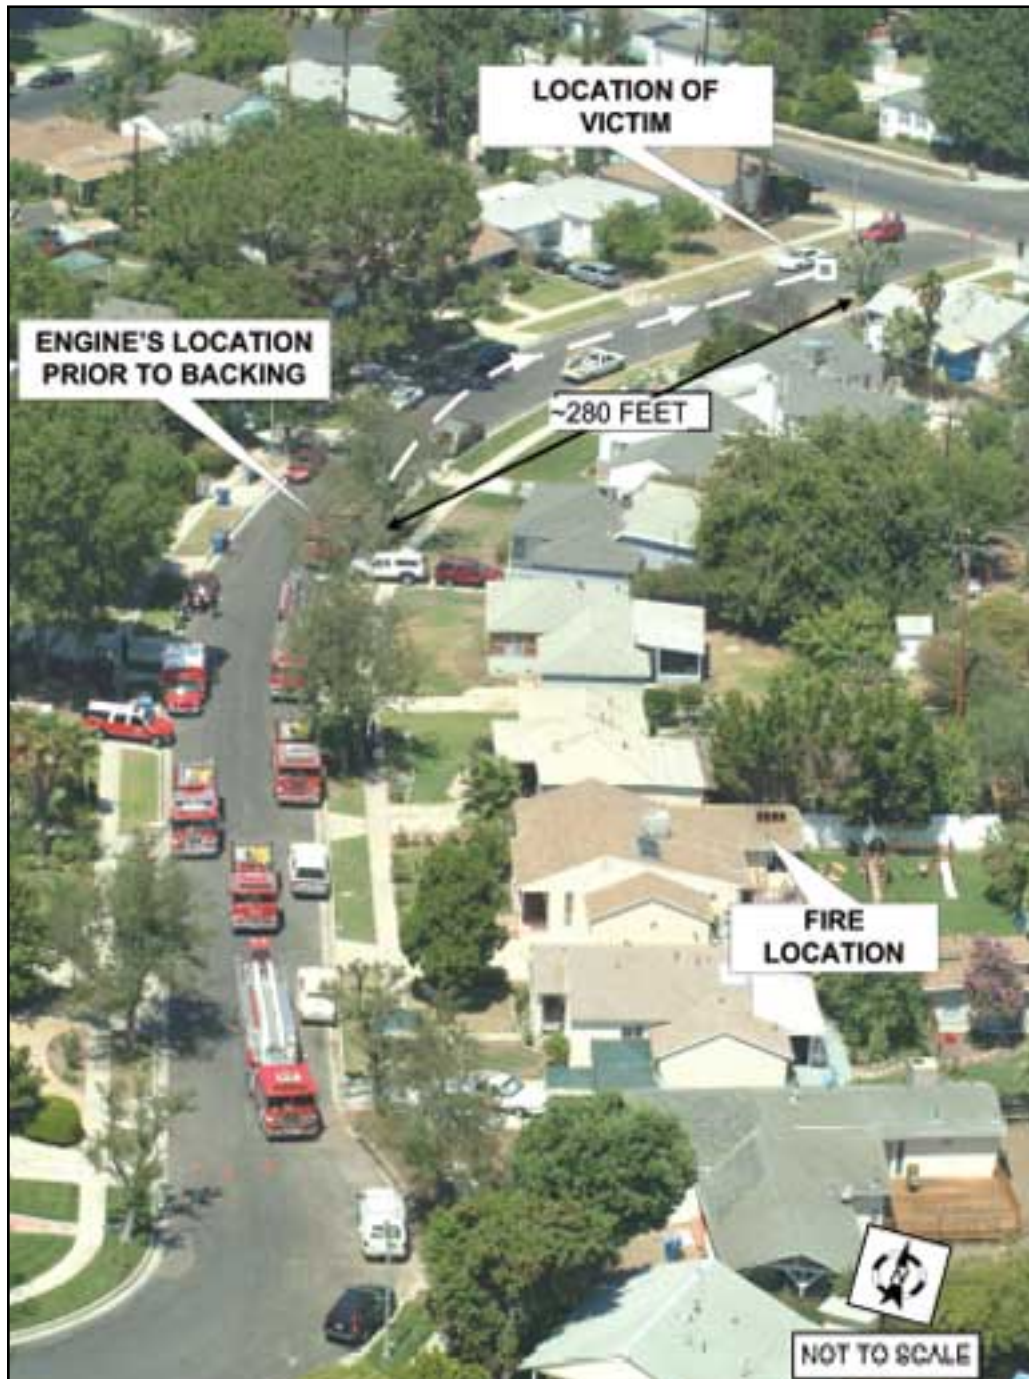
The crew returned to their apparatus, removed their gear, and rested for a few minutes as they drank water. The Incident Commander released the victim's crew from the incident at approximately 1330 hours, and because of other apparatus blocking the road, they were forced to back up to leave the fireground (see [Photo #1](#)).

**Photo 1. Recreated incident scene**

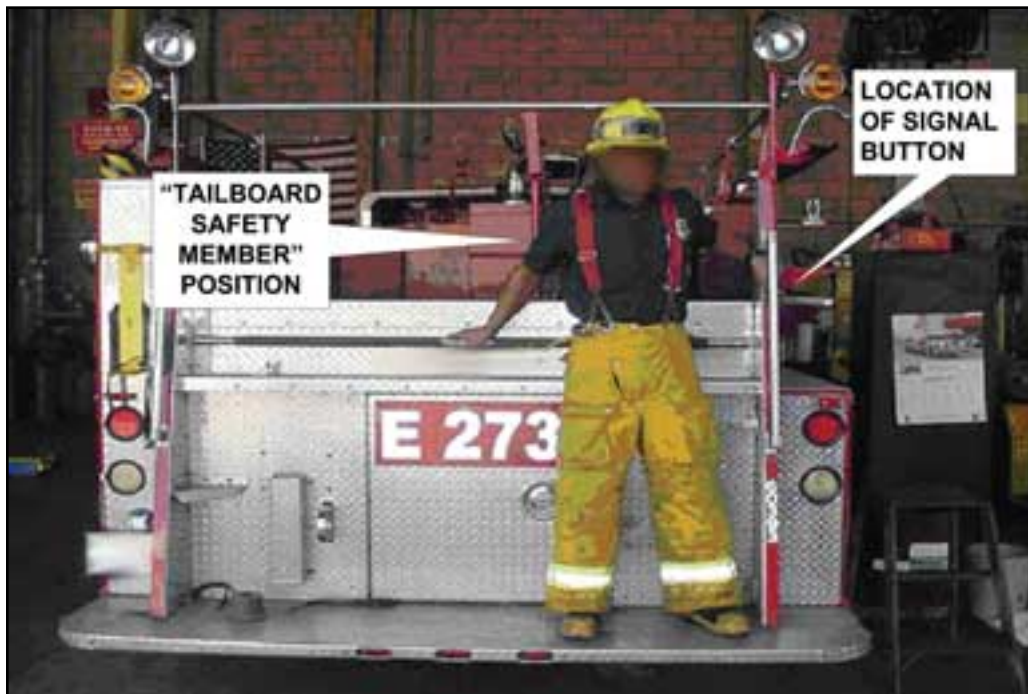
The victim took her position standing on the tailboard as the "Tailboard Safety Member," and as directed by department policy, notified the driver to begin backing up by pushing an electronic signaling button located on the rear panel of the engine. *Note: The fire department policy is for a fire fighter to ride on the tailboard and guide the driver whenever the apparatus is backing by pressing a signal button located on the rear engine panel. The "Tailboard Safety Member" would push the button once to stop,*

The department involved in this incident had a policy that required a member titled the “Tailboard Safety Member,” to ride on the tailboard and act as a spotter whenever the apparatus was backing. The spotter would face toward the rear while backing and communicate to the driver with an electronic signaling button located on the rear panel. A member riding in a standing position on the outside of the apparatus cannot be secured to provide any means of protection from a collision or a fall from the apparatus. For an unknown reason, the victim fell from the apparatus and was run over.

**Photo 2. Demonstration of victim's position and function just prior to incident**

***Recommendation #1: Fire departments should modify existing policies to prohibit members from riding on the tailboard or any exposed position when the vehicle is in motion.***

NFPA 1500 states “All persons riding in fire apparatus shall be seated and belted securely by seat belts in approved riding positions and at any time the vehicle is in motion. Standing or riding on tail steps, sidesteps, running boards, or any other exposed position shall be specifically prohibited.”<sup>1</sup>

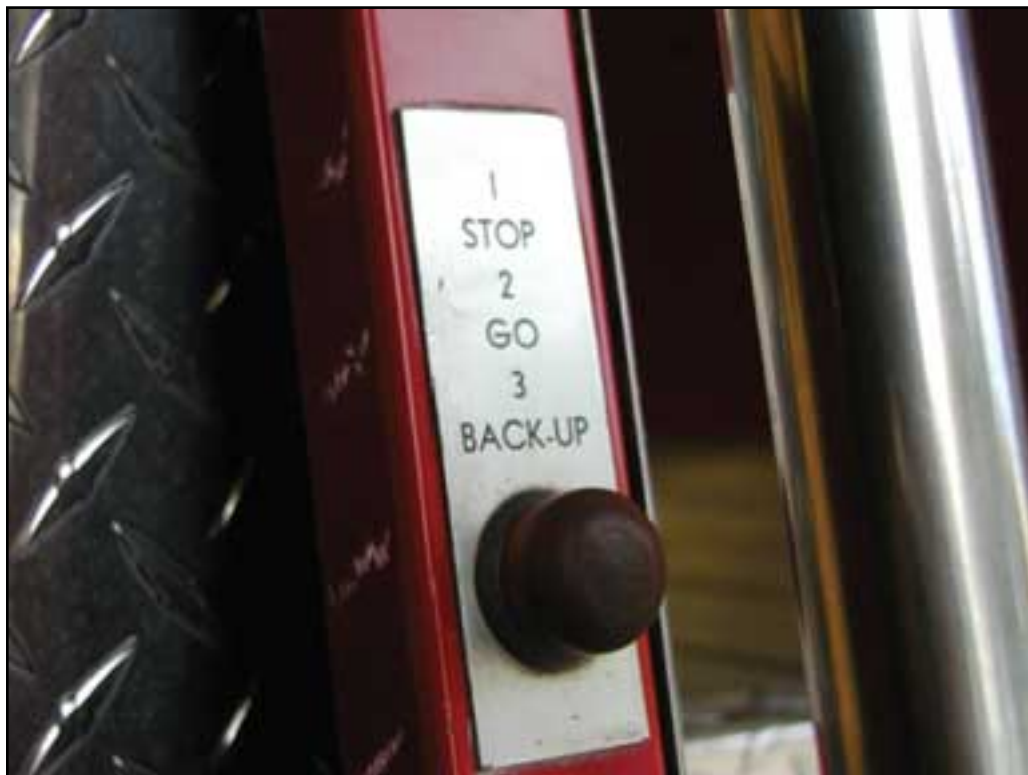
twice to go, and three times to back-up (see [Photo #2](#) and [Photo #3](#)). The signal button would sound a bell in the cab and a red light would also flash correspondingly on the dash (see [Photo #4](#)). A Captain, as directed by department policy, acted as the “Traffic Control Officer” and guided the backing operation from behind the apparatus, in the road on the driver’s side, by using hand signals.

**Photo 3. Push button on rear panel of engine with operating instructions**

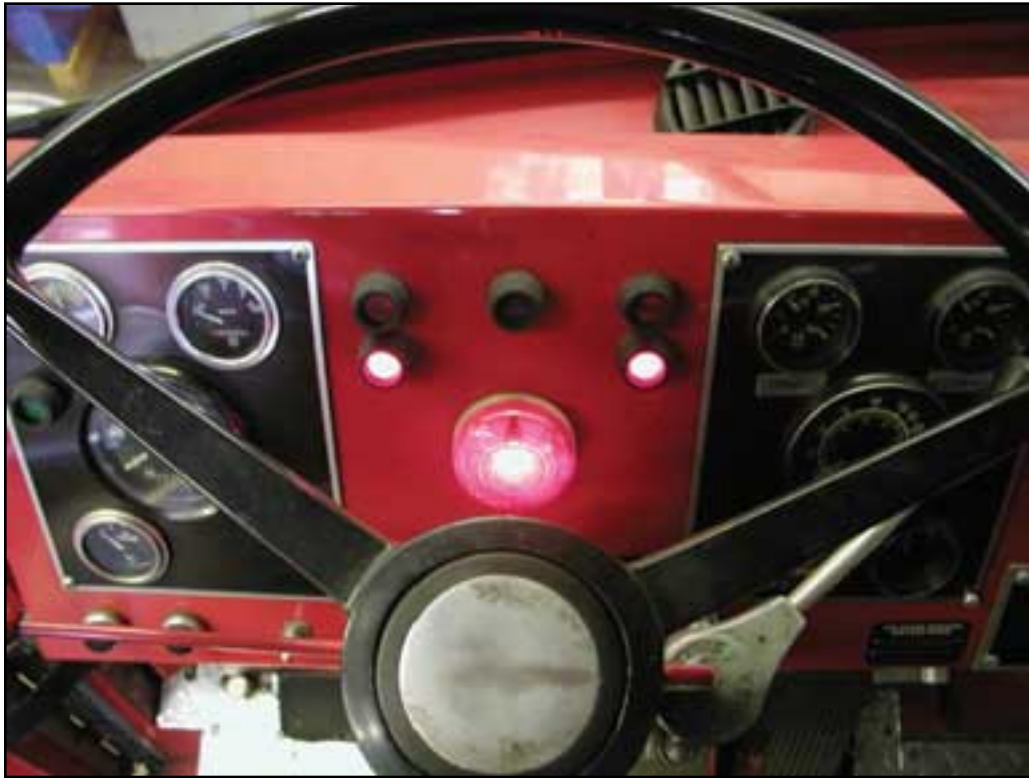
**Photo 4. Red light on dash that flashes when the electronic signal button is pushed**
