**NIOSH**  
Fire Fighter Fatality Investigation  
and Prevention Program

A summary of a NIOSH fire fighter fatality investigation

September 23, 2005

## One Part-time Fire Fighter Dies and Another Is Seriously Injured When Two Fire Engines Collide at an Intersection While Responding to a Fire - Illinois

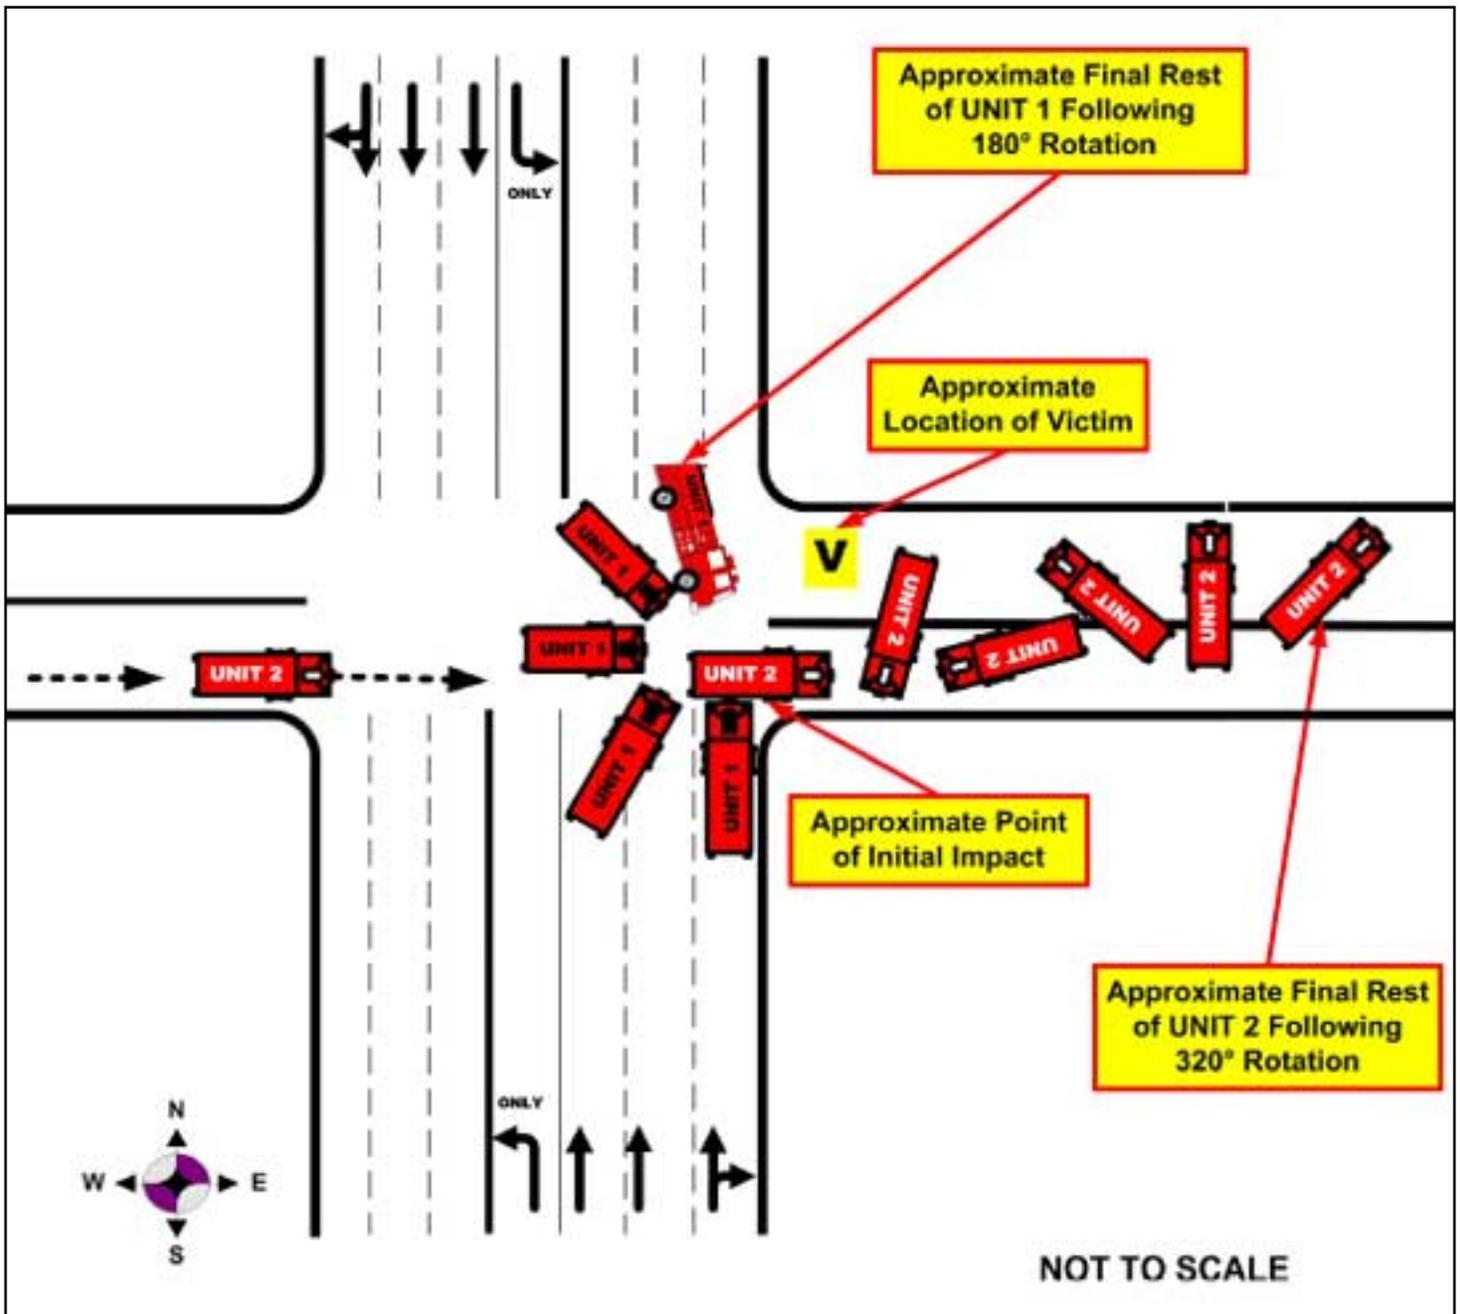
Weather/road: The incident occurred at the intersection of two concrete roadways bordered on both sides by raised concrete curbs. The east-west roadway (R1) has two lanes; the north-south roadway (R2) has three northbound and three southbound lanes. ([Diagram](#)). R2 has dedicated left-turn-only lanes on both the north- and southbound sides. Traffic at the time of the crash was reported as being of medium density. The crash occurred during daylight hours; the weather was clear and the roads were dry.

**Diagram. Aerial view of intersection where crash occurred**

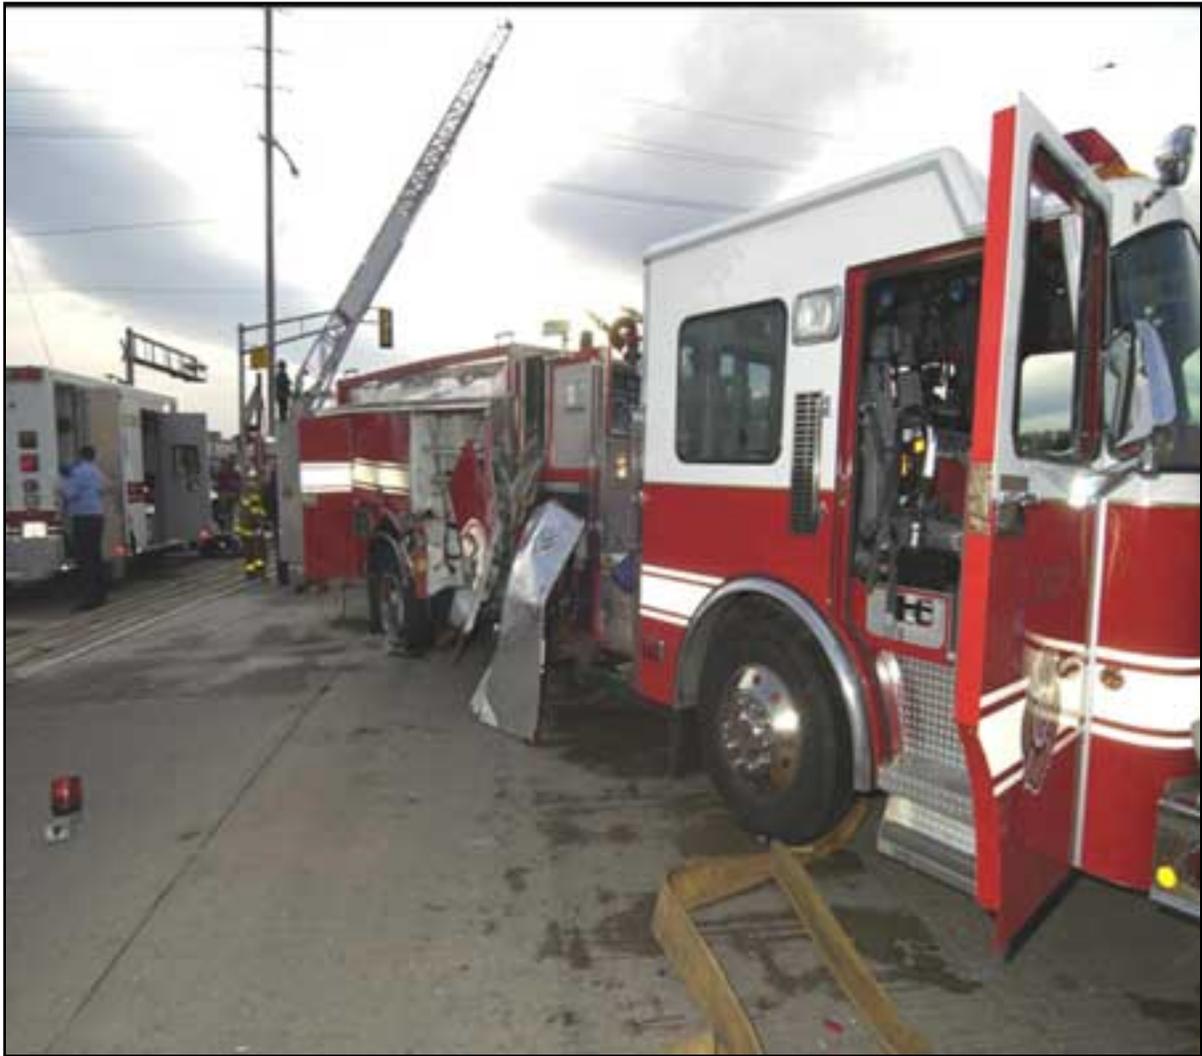
**Photo 1. View of Unit 2 which was struck on the passenger side**

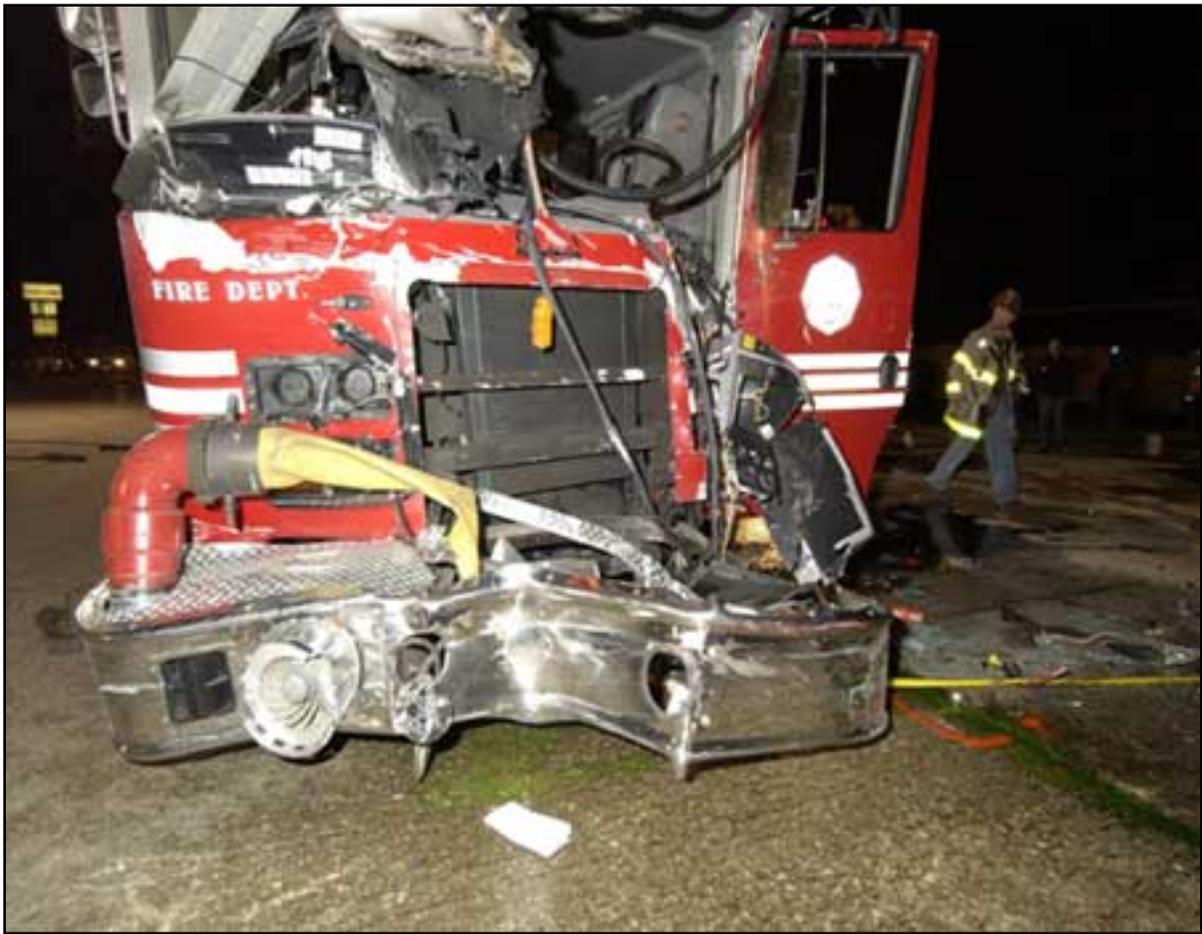
**Photo 2. Crushed front end of Unit 1**
