Case Study A

Beavercreek, Ohio

March 17, 2003

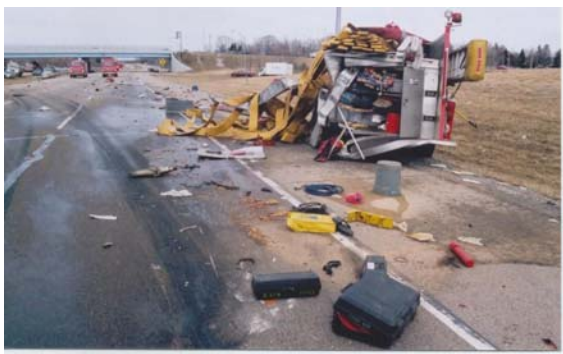
Figure A.3

The driver of the tractor-trailer reported the medic crew that he had just hung up his cell phone when he hit the engine. The accident caused debris field that littered all of the northbound lanes and the median for approximately two hundred and fifty feet from the point of impact (**Figure A.3**). Medic 2 received minor damage on the top of the patient care module and hood from flying debris. The passenger side, saddle tank from the tractor-trailer was torn from the truck and went spinning down the highway covering the exterior of Medic 2 with fuel before coming to rest in the median; approximately one hundred and fifty feet from the point of impact. Engine 4 was totally destroyed (**Figure A.4**). The proper placement of the fire engine created a safe work zone credited with saving all ten lives on the scene
