June 7, 2005

**BEAVERCREEK FIRE DEPARTMENT
SAFETY COMMITTEE
CRASH INVESTIGATION REPORT**

Date:.....3/19/03
Safety Committee No.:.....03-017
Location of Crash:.....North Bound 675 Just South of Indian Ripple Rd. Bridge
Apparatus Involved:.....Engine 4/41, Simon-Duplex/Allegheny
(Vin No. 1D91D61E6L1008170)
Medic 2, International 4700/Wheeled Coach
(Vin No. 1HTSLAAK3YH248880)
Civilian Vehicle Involved: Volvo Semi Tractor
Freight Trailer, (Make Not Reported)
Owner: Baylor Trucking
Other Vehicles at Crash
Scene, but not Involved:.....Beavercreek Police Cruiser
2 Civilian Vehicles
Personnel Involved:.....Engine 4 (Lt. Scott Dorsten #39, F.F. Ryon Cook #410)
Medic 2 (F.F. Greg Sanders #311, F.F. John Howard #424)
Date of Crash:.....3/17/03
Time Crash Reported:.....1356 Hours
Incident No. for Crash:.....03-0951
**Incident No. for Call That
Engine 4 and Medic 2 were
On When Crash Occurred:** 03-0950

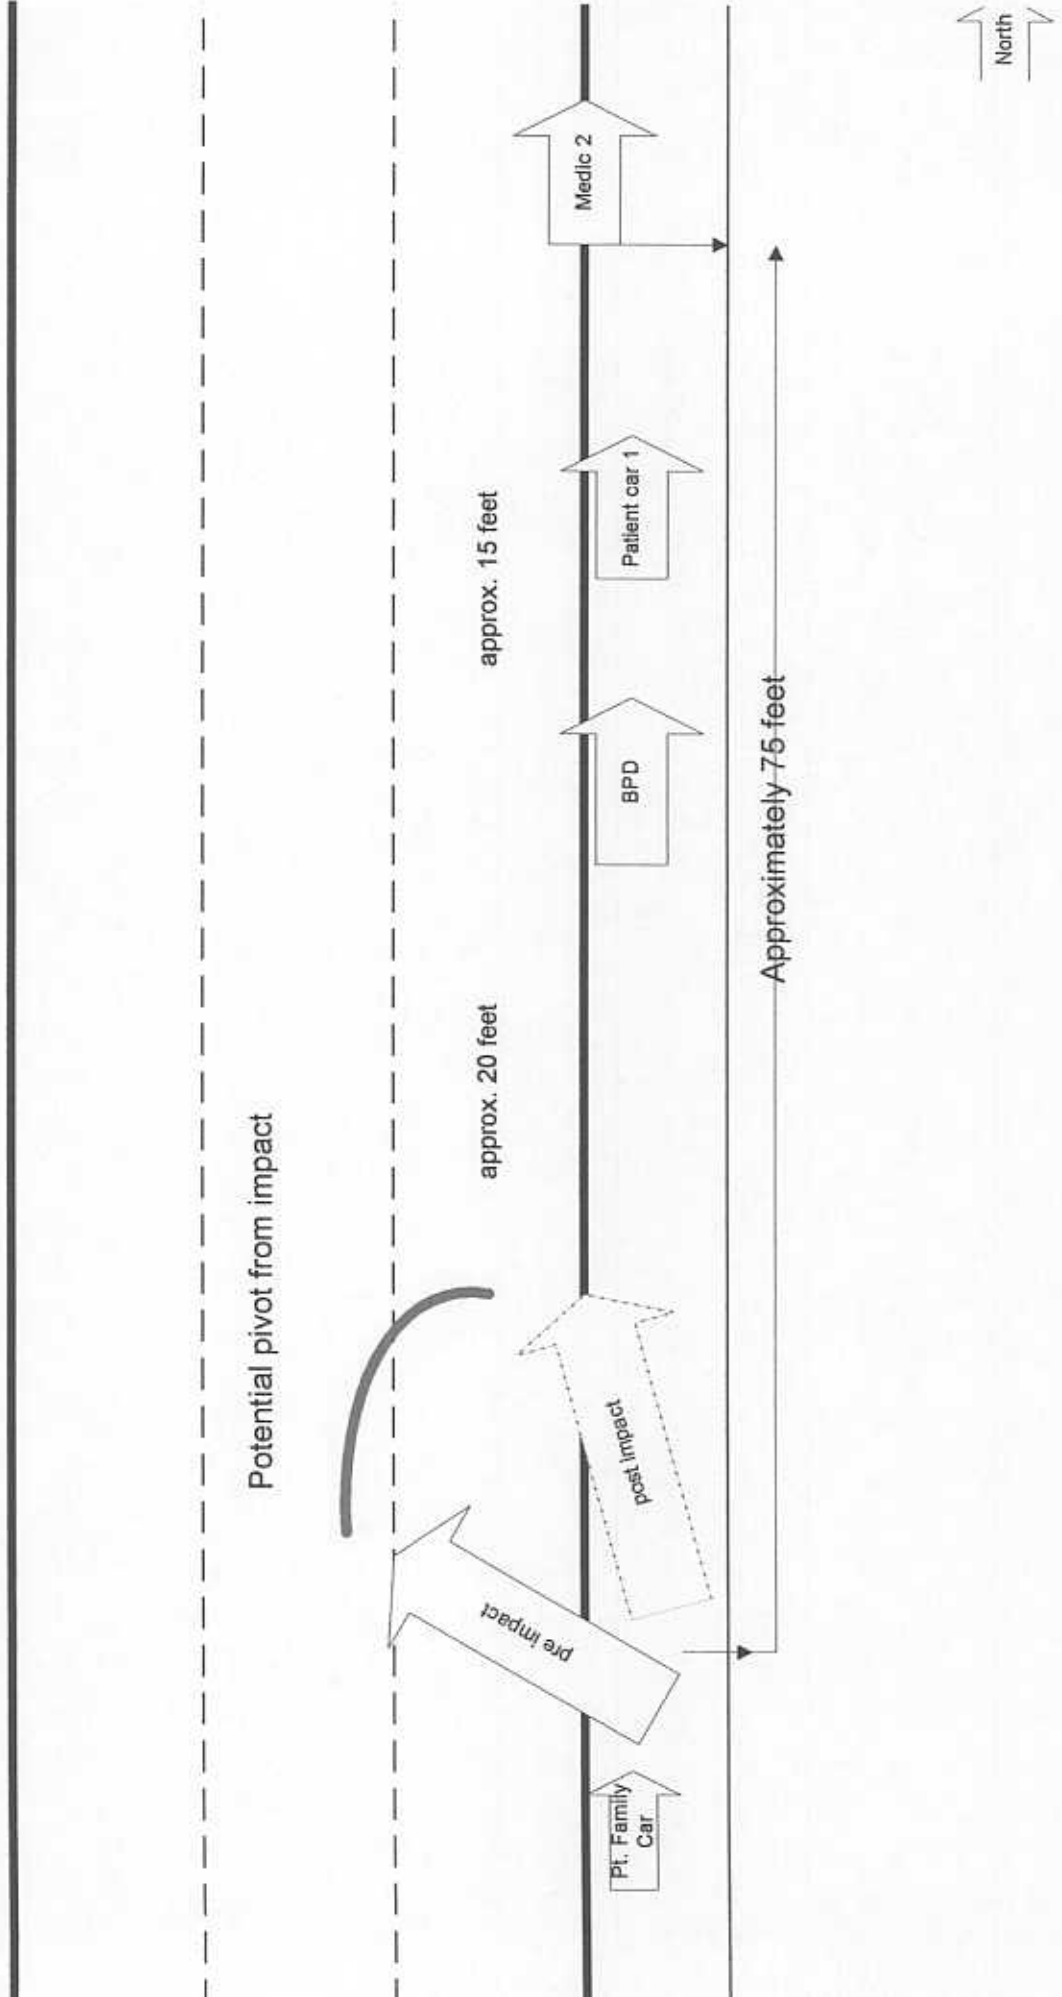
Possible apparatus movement with impact to the cab. When cab is placed in a position closest to the flow of traffic.

What are the chances of this occurring?

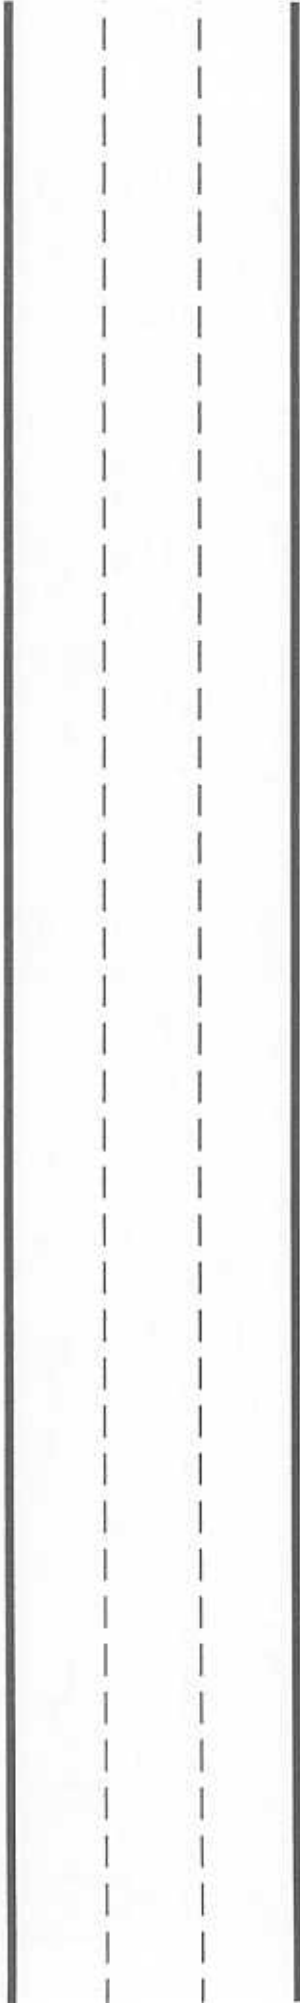
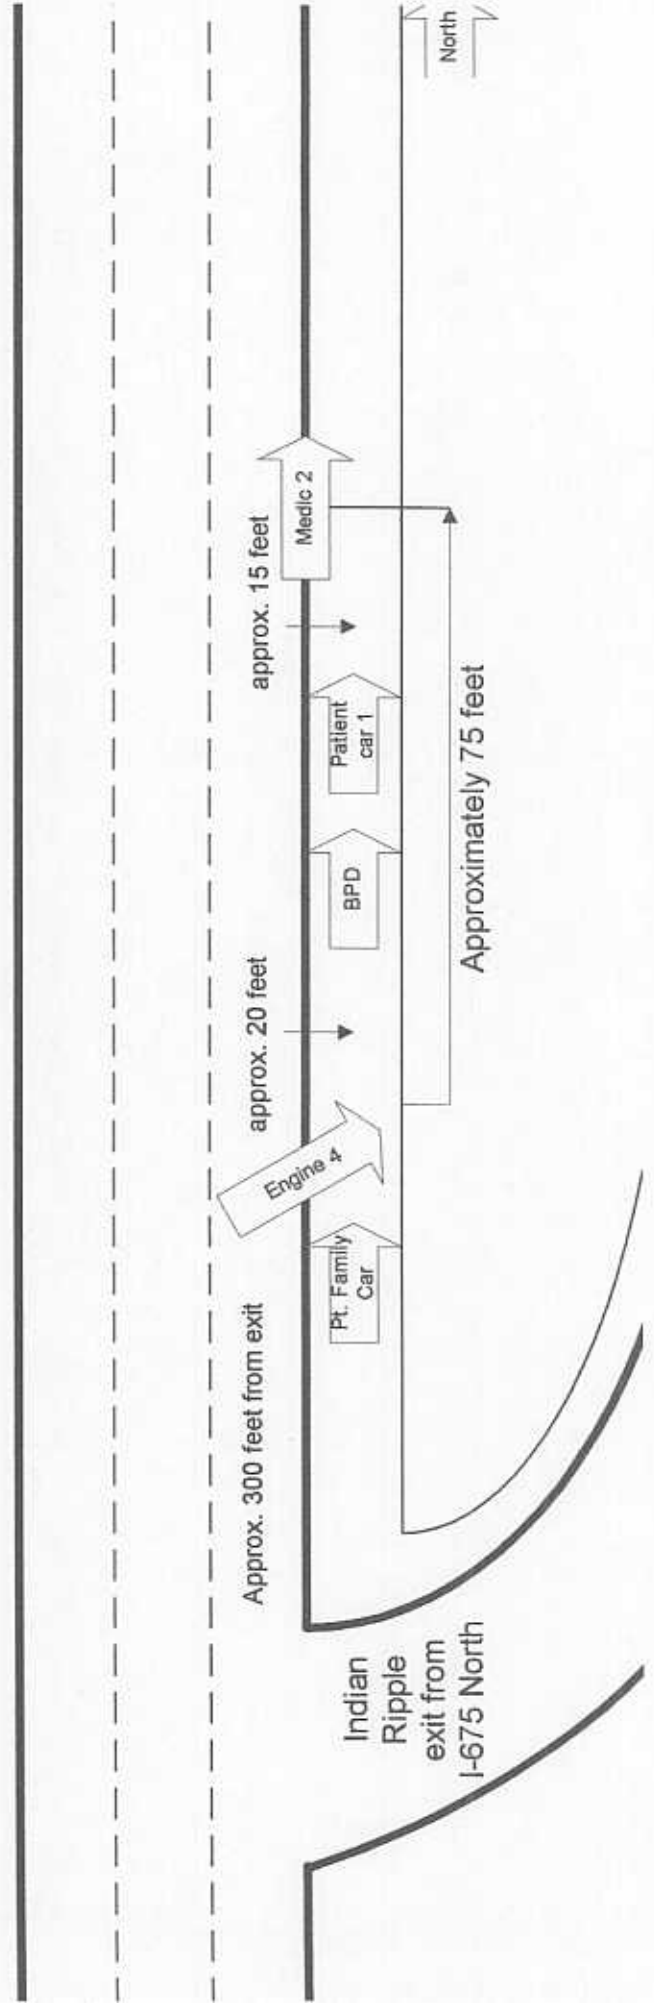
Indian Ripple on ramp to
I - 675 South

Tractor trailer
final position

Approx. 300 feet from exit

approx. 20 feet

approx. 15 feet

Approximately 75 feet

Engine 4
