## **Case Study D**

### **Kansas City, Missouri**

### **September 5, 2004**

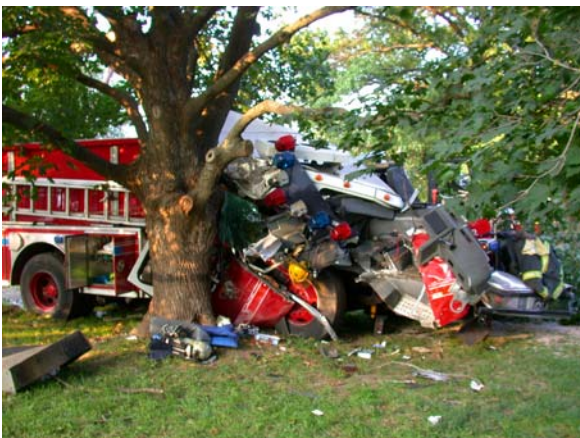
Figure D.3

As Pumper 33 approached the slowing vehicle they crossed left of center in an attempt to pass the vehicle. At that time, the slowed vehicle turned left towards the driveway and into the path of Pumper 33. Pumper 33 struck the vehicle with a glancing blow and veered across the northbound lanes of Blue Ridge Avenue (**Figure D.1**). Pumper 33 collided head-on with a 2<sup>nd</sup> passenger vehicle that had pulled over to the curb to yield right-of-way to the approaching fire engine (**Figure D.2**). After striking this vehicle, Pumper 33 sheared off a utility pole and then struck a large tree. The main point of impact was in front of the officer's seat position (**Figure D.3**).

In the ensuing investigation it was revealed that Pumper 33 was traveling approximately 51 mph at the time of the initial collision. It was also calculated that the pumper was traveling approximately 34 mph when it struck the second vehicle and 24 mph when it struck the tree. An inspection of the apparatus braking system revealed that the brakes were out of proper adjustment. The braking system had not been properly serviced for a period of 16 months before the collision. The KCFD maintenance program had been backlogged due to a severe shortage of reserve apparatus. The final report noted that the improperly adjusted brakes were not an issue with the initial collision. However, properly operating brakes should have been able to stop the apparatus before it struck the tree, which was the fatal blow for the acting captain in the passenger seat.

**2. Fire apparatus should undergo regular maintenance to ensure that all systems, including the braking systems, are operating properly.** All apparatus should be maintained in accordance with manufacturer's recommendations and specifications. This is especially crucial for systems that impact vehicle safety, such as the braking and steering systems. In this incident the faulty braking system would not have prevented the initial collision, but likely would have prevented the fire fighter fatality following the first crash.
