NIOSH
Fire Fighter Fatality Investigation
and Prevention Program

A summary of a NIOSH fire fighter fatality investigation

June 3, 2005

Forest Ranger/Fire Fighter Drowned After Catastrophic Blow-out of Right Front Tire - Florida

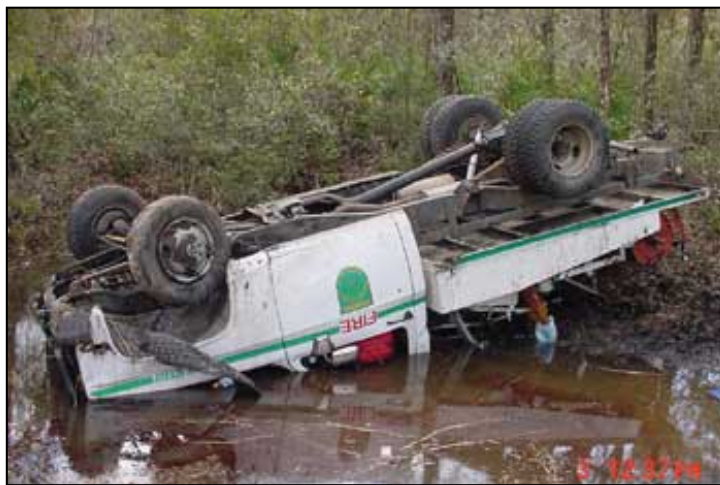
On March 3, 2004, a 40-year-old male forest ranger (the victim) died after he lost control of the brush truck he was driving to a controlled burn. The truck experienced a catastrophic blow-out of the right front tire, left the road, struck a culvert and overturned. It came to rest on its roof in a ditch filled with approximately 2 feet of water. The victim was pronounced dead at the scene.

Overtured truck

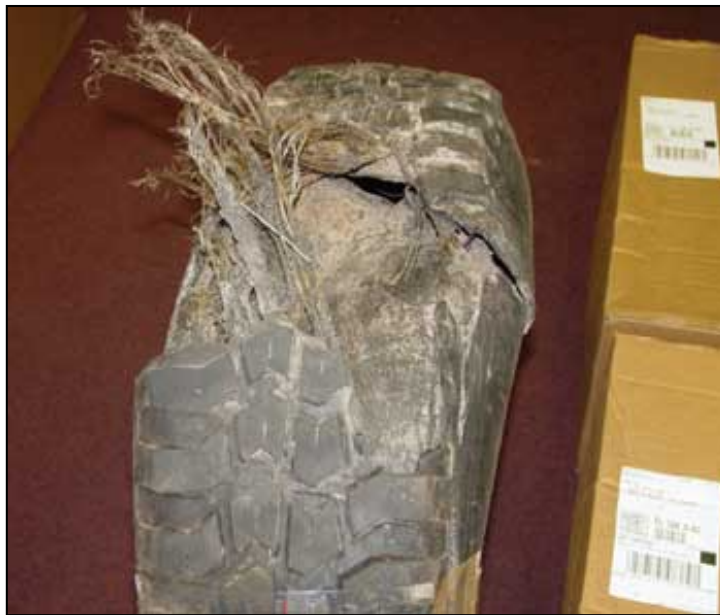
A post-crash examination by the crash reconstructionist determined the tire had undergone a catastrophic, burst type blow-out that compromised the casing integrity (radial casing cords), inner radial ply and liner. Tread depth of this tire was 9/32. According to the reconstructionist, the tire damage resembled similar damage documentation patterns resulting from a previous impact that may have compromised the inner tire radial ply and liner. The reconstructionist stated in his report that this type of damage is *nearly impossible to detect* because tires may still hold air and show no outward signs of deformation. He also noted that, post crash, there was *considerable tread deformation and separation along with complete cord disruption at the blow-out epicenter* ([Photo](#)).

Photo. Right front tire after blow-out.

Recommendation #2: Fire management agencies and fire departments should, as part of the apparatus maintenance program, ascertain the age of tires and impose time restrictions for usage according to manufacturers’ specifications and guidelines.

Discussion: Tires should be checked for signs of wear, for drying or cracking, for cuts, proper pressure inflation, adequate tread depth, and condition of the valve stems. As with any rubber product; however, degradation of tires occurs with age, regardless of tread depth and use.^{5, 6} States with high average ambient temperatures have higher tire failure rates.⁶ Thus, imposing time restrictions is important. The tires in this incident were six years old and, according to the reconstructionist, showed no signs of degradation or excessive tread wear. However, neither the division nor the fire department from which the division bought the donor vehicle could document the age of the tires.

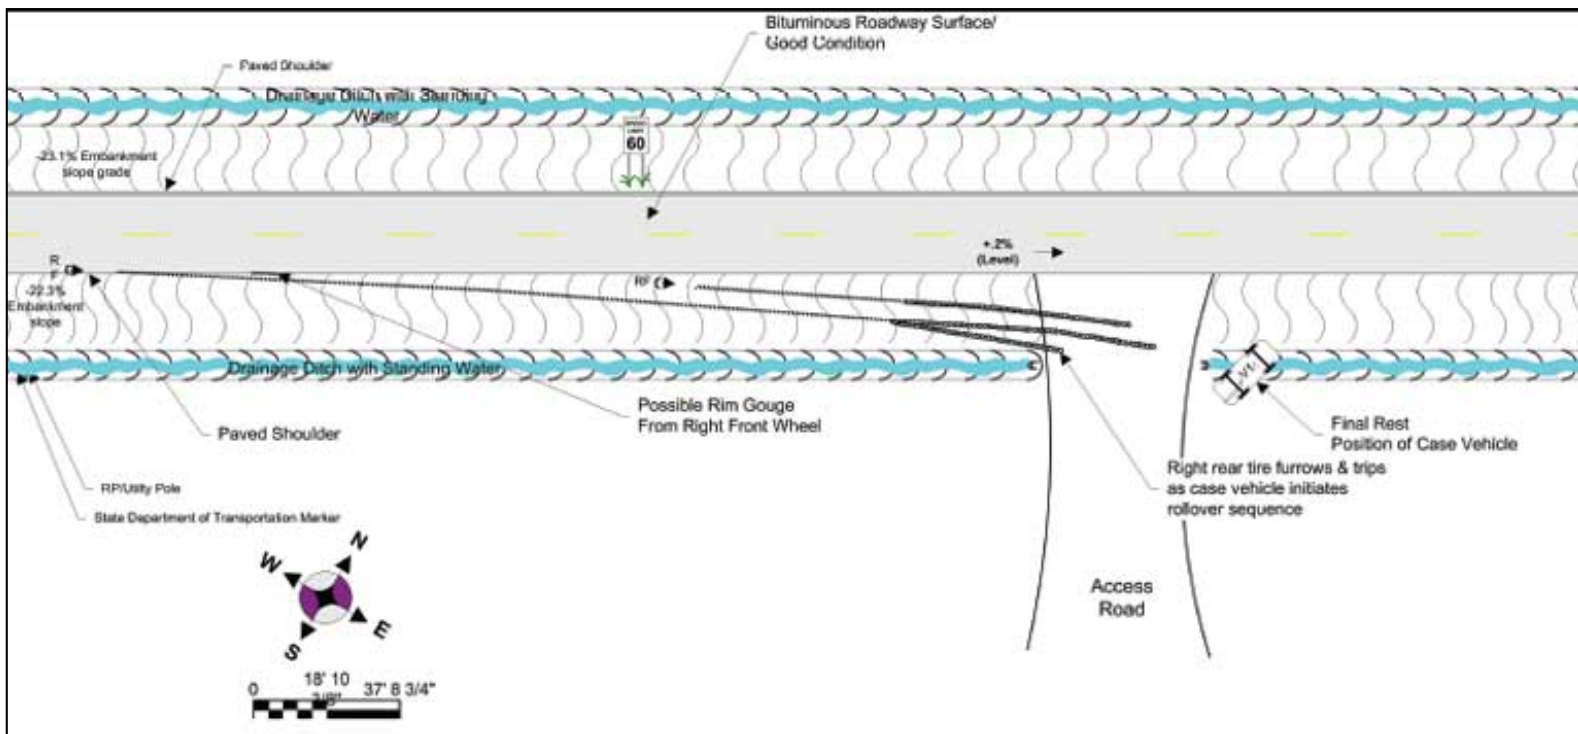
On March 3, 2004, at approximately 0900 hours, the victim was traveling northeast on a two-lane road to conduct a controlled burn when his right front tire experienced a catastrophic burst-type blow-out causing him to lose control. The incident occurred on a long, straight section of level road. The victim was familiar with the vehicle, the road and the area. His estimated speed at the time of the incident was 55 mph based on the reported speed of a witness traveling behind the victim. The truck left the roadway, rotated counterclockwise, hit a culvert, and overturned ½ turn coming to rest on its roof in a ditch ([Diagram](#)). The drainage ditch contained approximately 2 feet of water at the time of the incident. The victim, who was wearing his seatbelt, was suspended upside down from his seatbelt with his head submerged beneath the water. He apparently was unable to unbuckle his lap and shoulder restraint and drowned.

Diagram. Aerial view of incident scene.
