# STATE FIRE MARSHAL'S OFFICE

## Firefighter Fatality Investigation

**Investigation Number 05-307-04**

**Firefighter Christopher Brian Hunton**  
**Amarillo Fire Department**

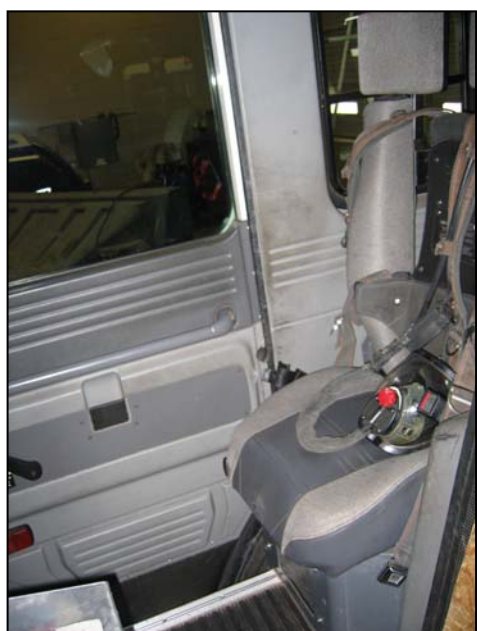
The lap belt on the seat in which firefighter Hunton was riding was unbuckled and retracted. The safety belt appeared to be in functional condition with no binding or other impediments to use. The safety belt on the right rear-facing crew seat was buckled around the seat cushion in a manner that indicated it was not customarily worn. There are warning signs in several location in the cab area emphasizing the need to be seated and to wear safety belts when the vehicle is in motion.

(Left) Left rear crew seat and (above) warning label in crew compartment. (Below) Right rear seat.

**Recommendation:** Firefighters should follow departmental policy by donning all protective equipment and fastening their safety belts prior to moving the apparatus.

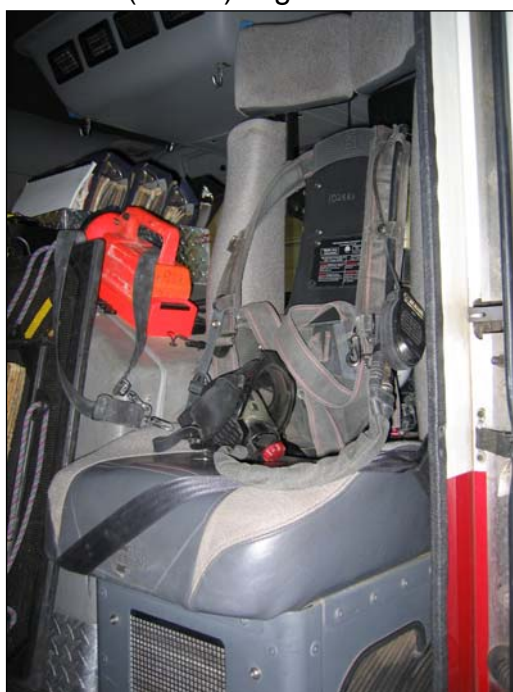
Ladder 1 is equipped with a safety belt monitoring system with an audible and visual alarm to indicate if a safety belt is not fastened in an occupied crew seat. The monitoring system was not functioning and the sensor wiring on the right rear jump seat was disconnected. No further examination of the system and seat sensors was conducted by SFMO, pending an engineering evaluation of the vehicle and left rear door latching mechanism.

**Recommendation:** Existing safety monitoring systems on apparatus, while not required, should be maintained in operable condition to enhance personnel safety and to avoid a false perception of safety. All fire apparatus should be inspected at least

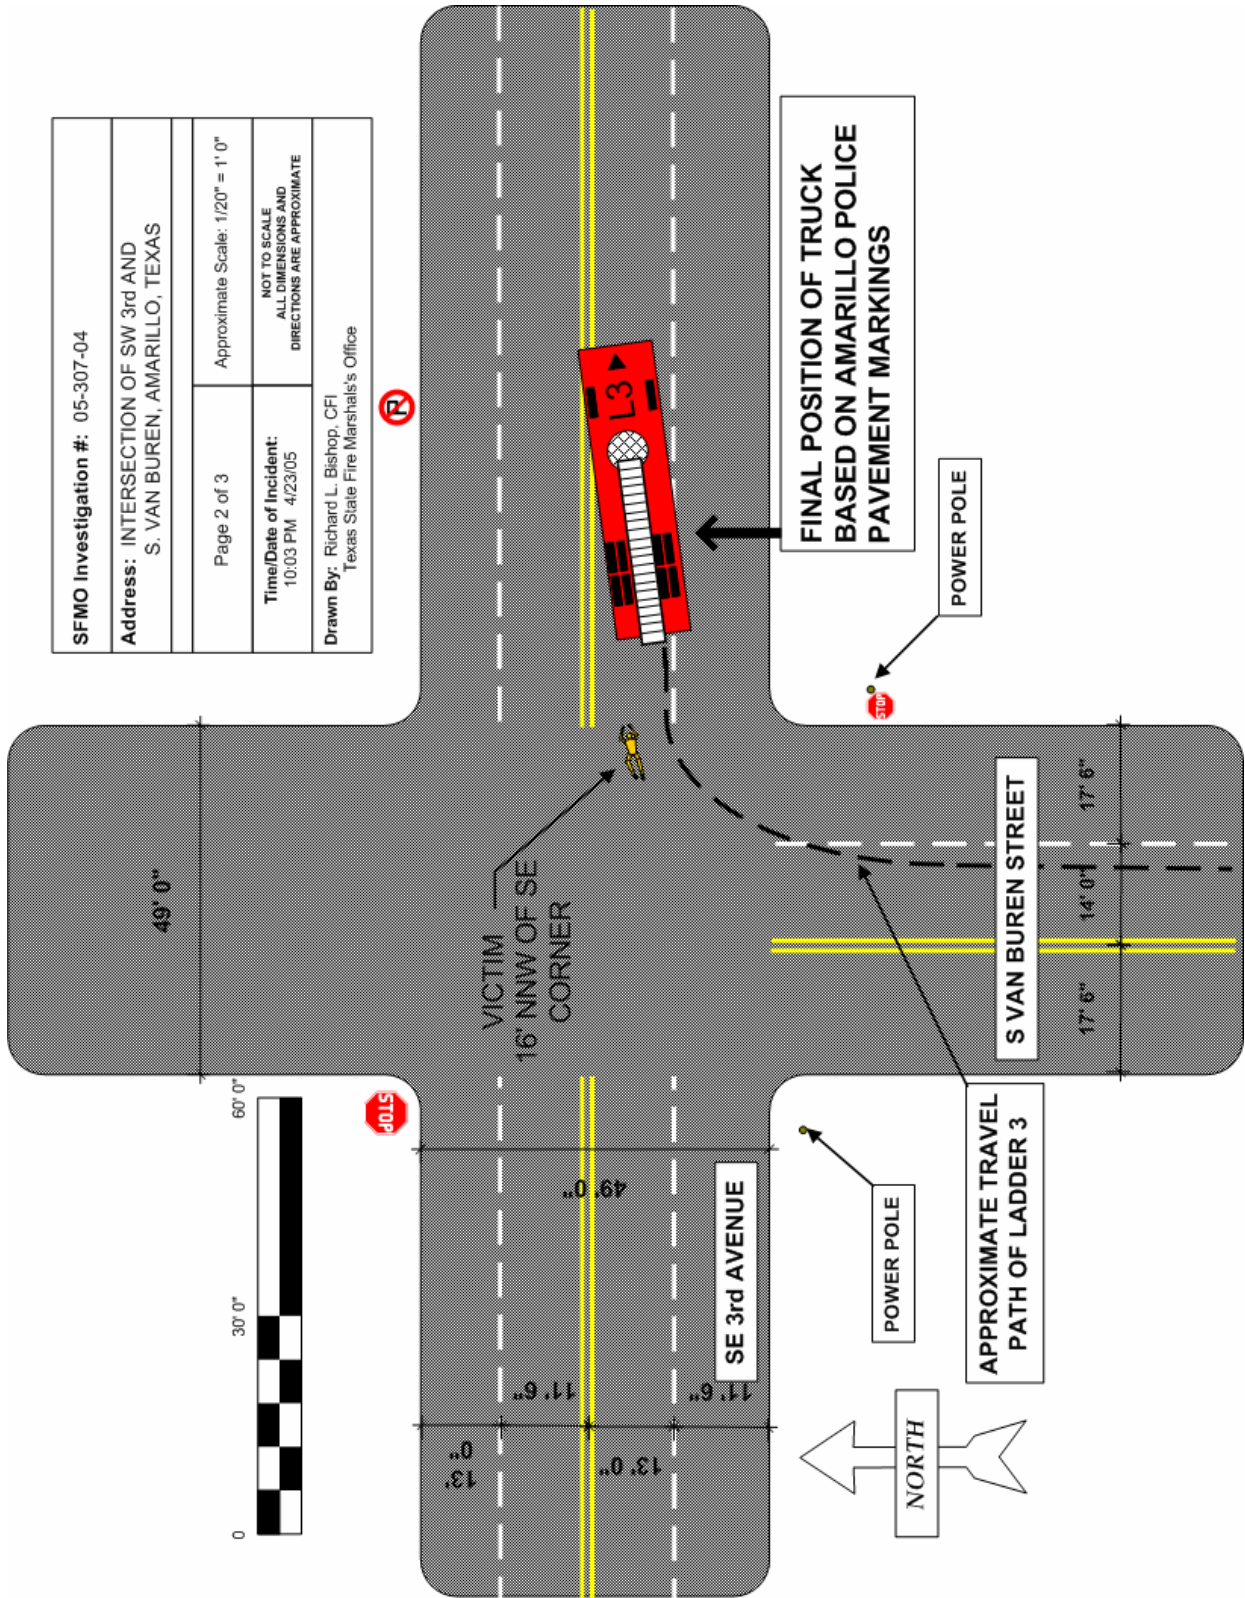
The Amarillo Police Department did not make any measurements at the incident scene other than those used to construct a diagram showing the location of firefighter Hunton in the intersection of 3<sup>rd</sup> and Van Buren. The Police Department did mark the location of the tires of Ladder 1 after it stopped, and these markings, combined with the police report diagram, were used to construct the SFMO diagram of the scene on April 28, 2005. (Diagram located at the end of this report)
