NIOSH Respirator User Notice

June 12, 1998

Breathing Tube Inspection Procedure

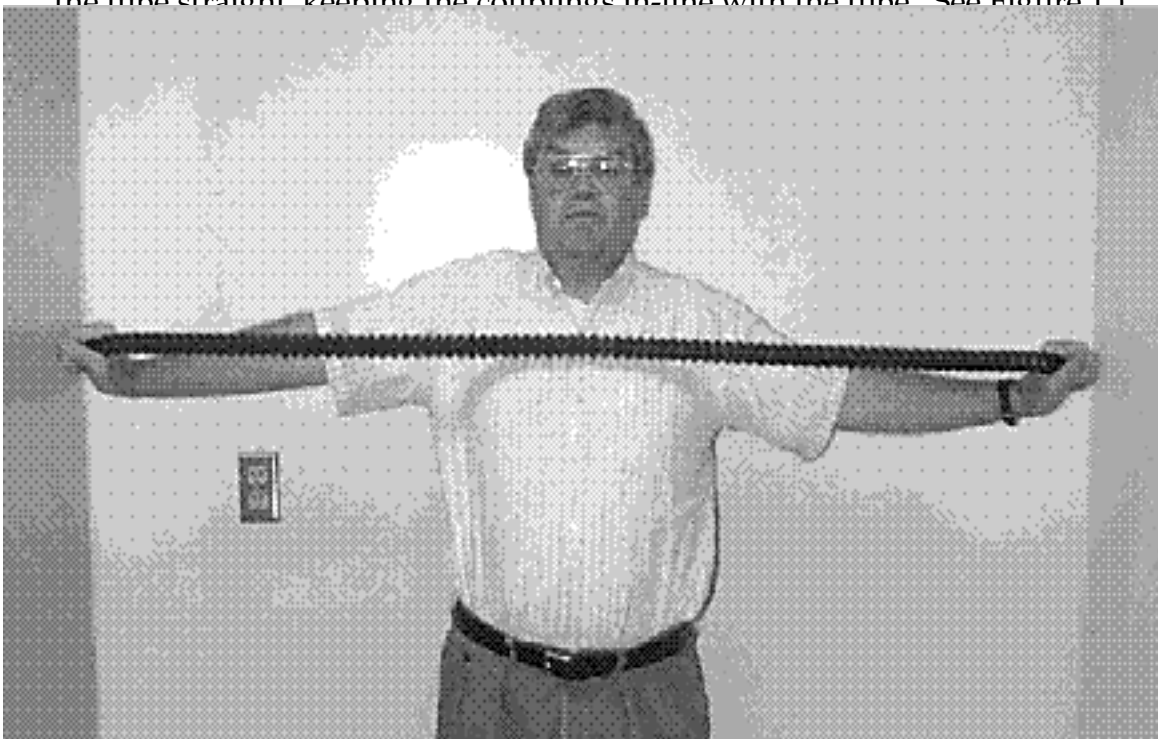
Figure 1: Proper Pull Technique

1. With palms down, firmly grasp the end couplings.
2. Stretch the tube by drawing the end couplings away from each other until the tube is stretched to a distance of greater than 5 feet but not to exceed 6 feet. (Pull the tube straight, keeping the couplings in-line with the tube. See Figure 1.)

3. Hold for 10 seconds.
4. Release the tube.
5. Inspect the tube per MSA's published instructions.

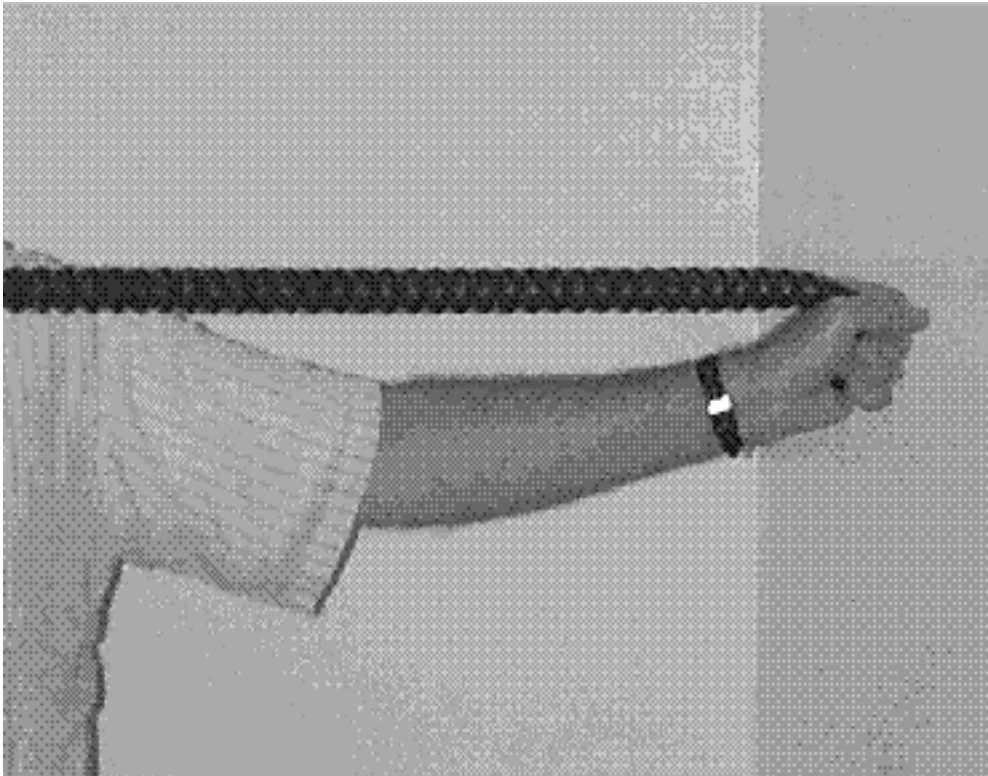
Figure 2: Improper pull technique

Do not bend end couplings as shown in Figure 2.
