RESEARCH AND DEVELOPMENT REPORT

Evaluation of Flame Propagation of Retrofit Energy Efficient Wall Assemblies

April 19, 2024

Prepared for the International Association of Fire Fighters in fulfillment of Department of Energy Grant DE-E0009454

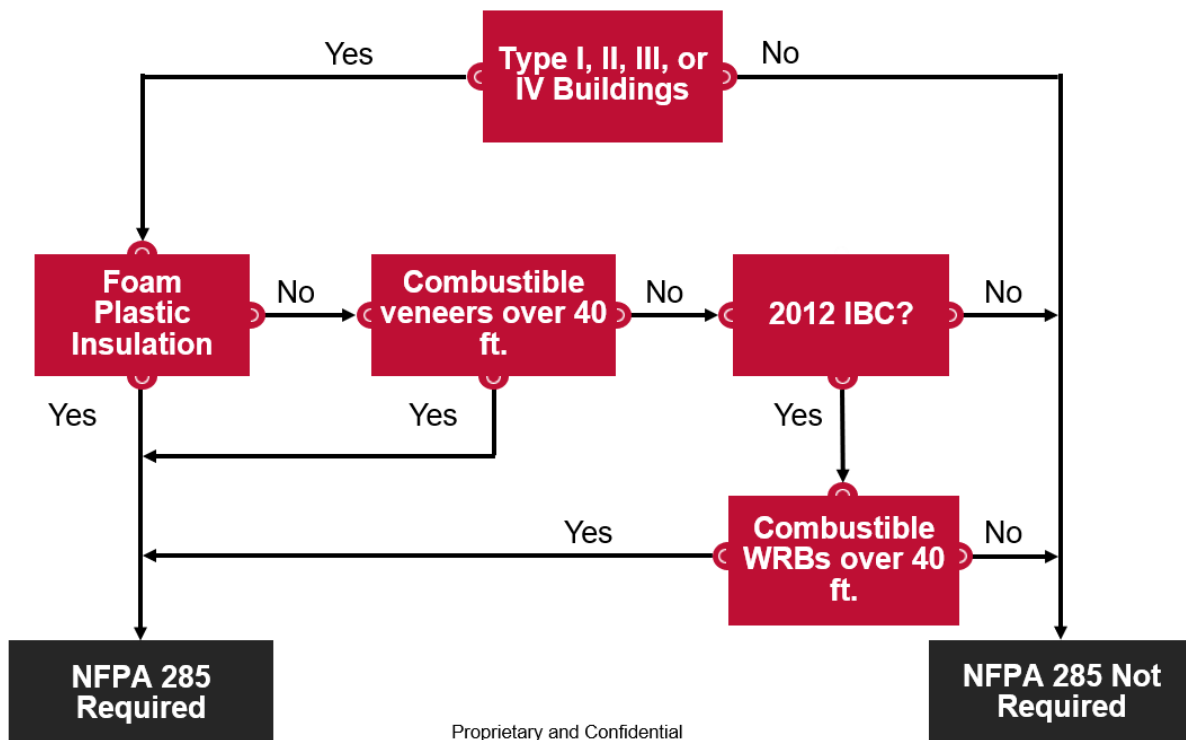
Figure 1 - Wall Assembly Conditions Requiring Testing to NFPA 285

Requirements for exterior fire propagation of building construction can be found in the IBC and NFPA 5000. There are five types of construction within the IBC and NFPA 5000: Type I, Type II, Type III, Type IV, and Type V. These were formerly referred to as Fire Resistant, Non-Combustible, Ordinary, Heavy Timber, and Wood-frame. The building types generally start with the most fire resistant construction and progress to the least fire resistant. Types I through IV specifically require wall assemblies to be tested to the fire tests in NFPA 285 given the conditions outlined in Figure 1. Type V construction is not specifically addressed in either code for this purpose. The majority of one- and two-family dwellings are under 40 ft in elevation, and these constructions are addressed in the International Residential Code, which also does not require NFPA 285.

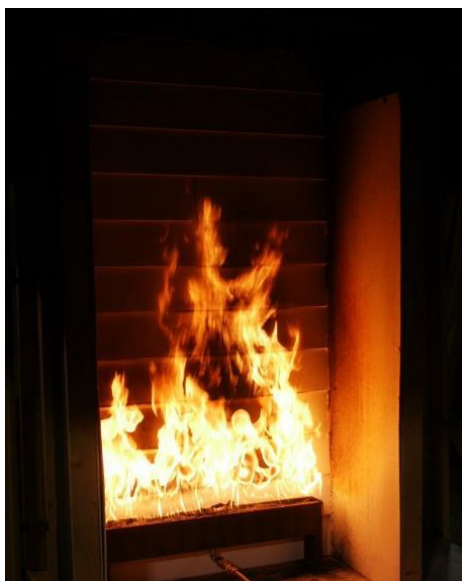
Figure 3 - Photograph of ASTM E2707 Test

The test method defines the test specimen to be 4 ft (1.2 m) by 8 ft (2.4 m) in size. The fire source is a slotted gas burner set to 150 kW placed at the bottom of the test specimen such that the flame can impinge on the exterior of the test specimen. The specimen is exposed to the fire for 10 minutes. The test specimen is observed for the absence of flame penetration through the wall assembly & absence of glowing combustion on the interior surface at the end of the 70-minute test (1 hour observation period).

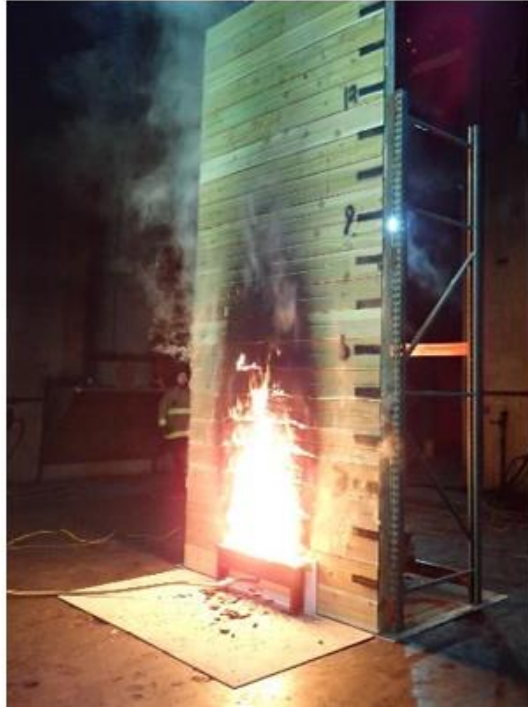
Figure 11 - Photograph of a Modified ASTM E2707 Fire Experiment

Eight co-sponsored experiments were conducted to refine the draft, modified ASTM E2707 test method. These experiments studied four different ignition burner fire sizes with a combination of different common exterior wall materials. Some experiments were conducted with insulation and interior gypsum board and others without. The sidings investigated were vinyl and 8 inch (20 cm) wood lap siding. Three WRB conditions were investigated - polyethylene fiber barrier, construction paper, and none. Oriented strand board (OSB) or plywood was used as sheathing. In the tests with insulation, fiberglass was used. Lastly in one test, 1 inch (25 mm) extruded polystyrene (XPS) was applied under the vinyl siding to simulate continuous insulation. In each experiment the wall assembly was wood framed and 8 ft (2.4 m) wide and 16 ft (4.9 m) in height. 2 by 4 lumber was used. The studs were 16 inch (41 cm) on center. The siding was attached with fasteners at a nominal 8 inch (20 cm) on-center and included staggered joints at vertical centerline of assembly. The same line burner (Figure 10) used in the UL FSRI study was used in this series of experiments. The burner was left on for 20 minutes in each test. The experimental test matrix can be found in Table 3. A photograph of an experiment is presented in Figure 11.

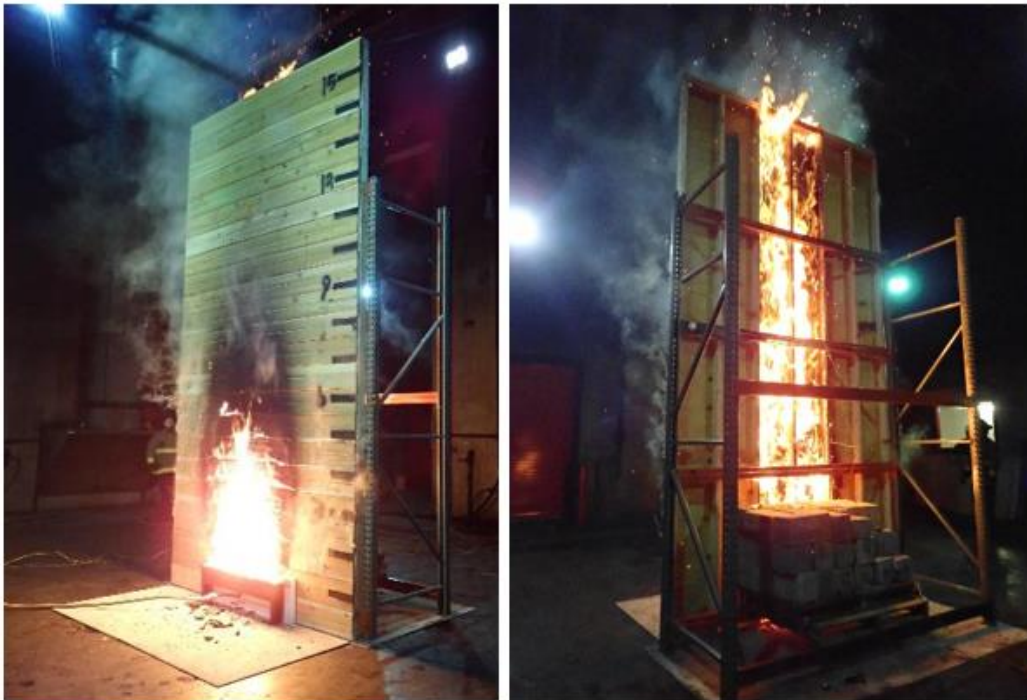
Figure 12 - Photographs of Fire Burning through Test Sample

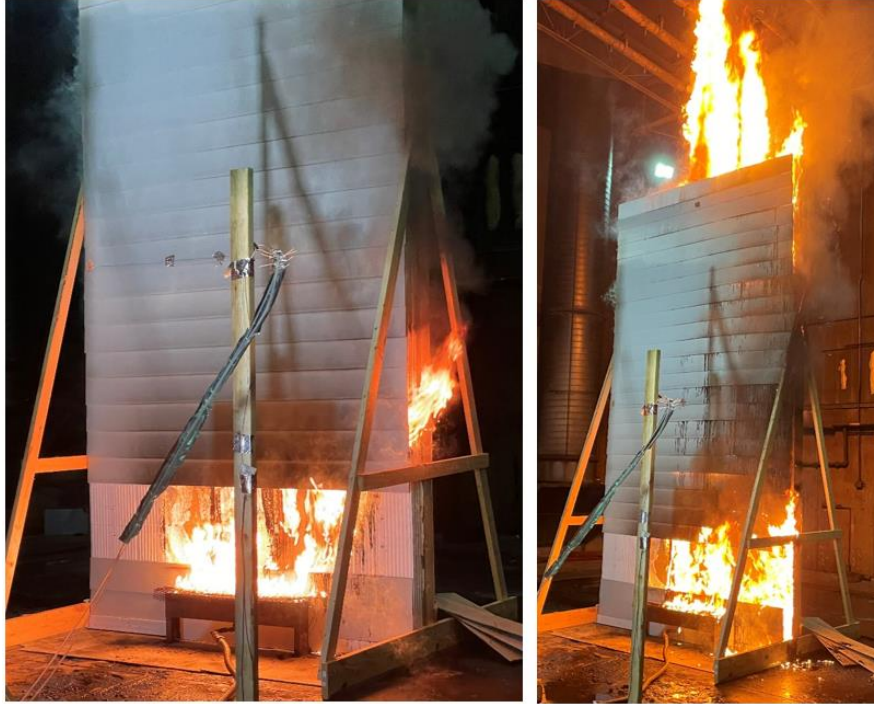
Figure 36 - Photograph of Test 7 with Fiber Cement Siding Panels Removed Showing Interior Fire Spread

The purpose of this test series was to evaluate exterior flame propagation. While this is an extreme example, penetrations in siding can alter the fire performance of wall assemblies. Penetrations can be caused by window or door installations, installation of electrical outlets, and wear and tear from age, for example. The impact of penetrations on wall assembly fire performance is an area of potential future study.

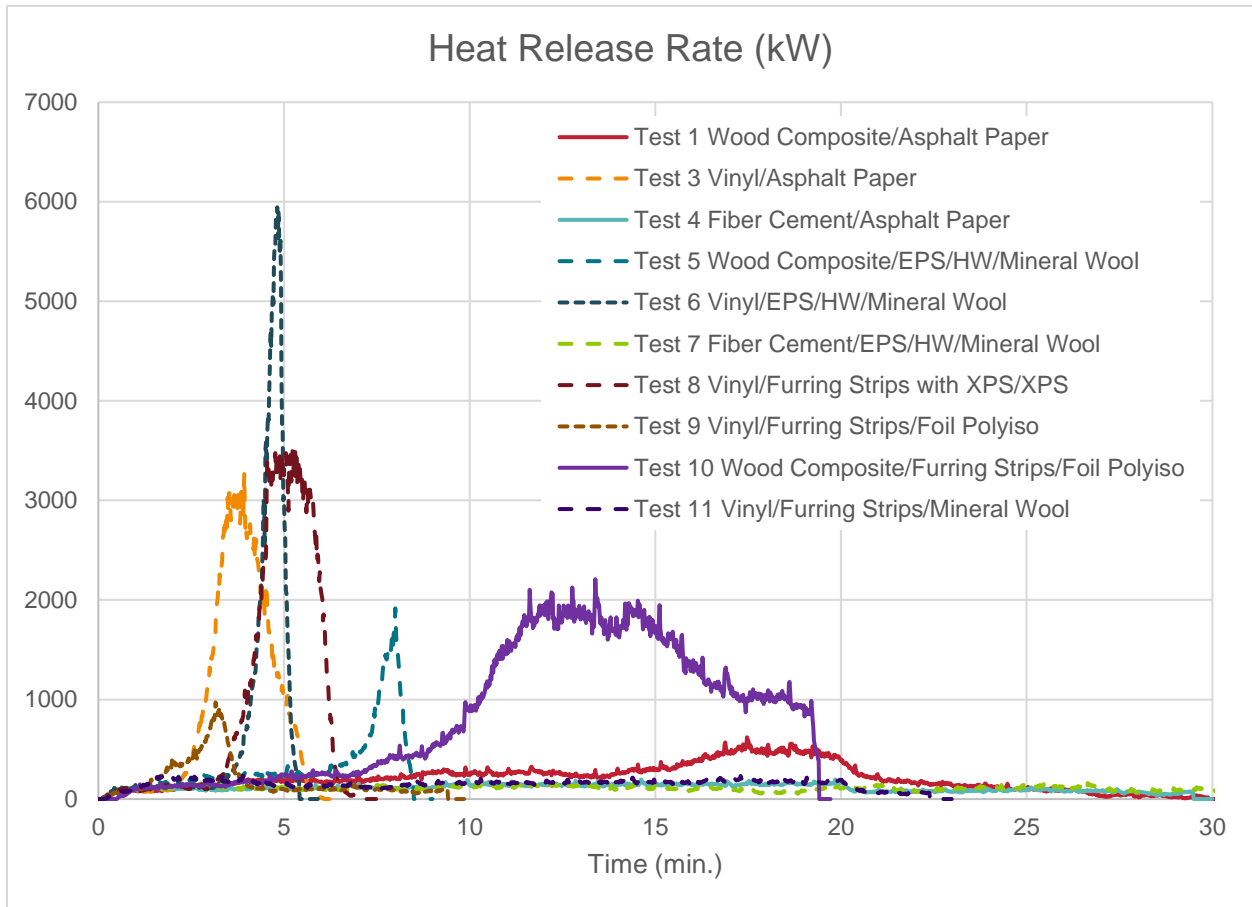
Figure 38 - Heat Release Rates over Time for Tests with 75 kW Ignition Source

The HRR data for each test with a 75 kW ignition source is shown in Figure 38. While several tests were terminated early (Tests 3, 5, 6, 8, 9, and 10), the data does provide some insight into the difference in fire growth and size between more and less combustible assemblies. The highest recorded HRR was 6,000 kW and the lowest was 200 kW (including the 75 kW contribution from the burner).

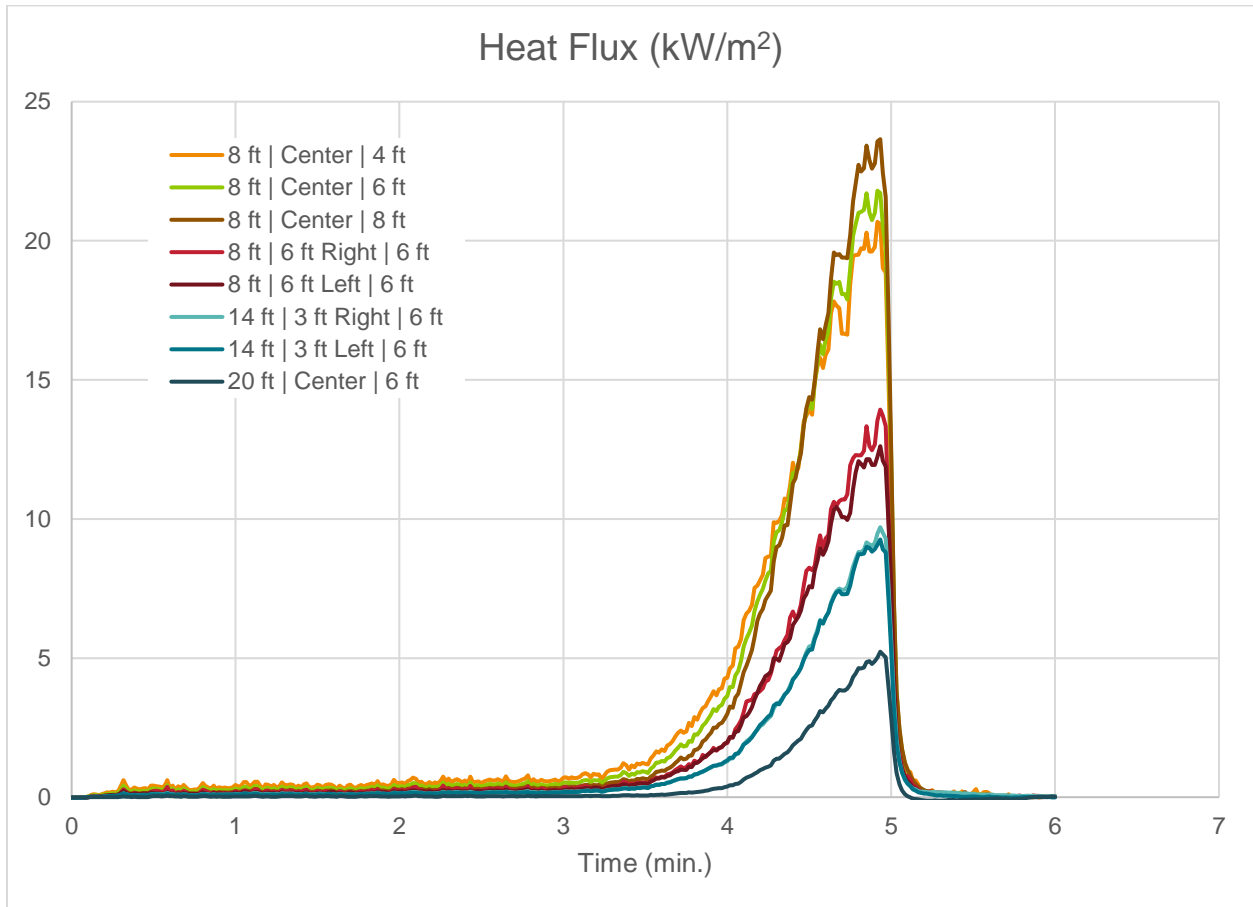
Figure 39 - Test 6 Vinyl Siding/EPS/Mineral Wool Heat Flux Plot

The highest heat fluxes measured in the test series were recorded in Test 6 - the wall assembly with vinyl siding, wood furring strips and EPS insulation, over house wrap, and a layer of mineral wool. The peak heat flux, 24 kW/m^2 , was recorded in the center of the wall assembly, 8 ft (2.4 m) away from the assembly, and 8 ft (2.4 m) above the top of the burner. At 8 ft (2.4 m) from the center of the wall assembly, heat fluxes in excess of 20 kW/m^2 were recorded at all three elevations. 20 kW/m^2 is commonly accepted as the heat flux threshold for the onset of flashover within a room [15]. It is possible to ignite another structure at this distance from the wall assembly.

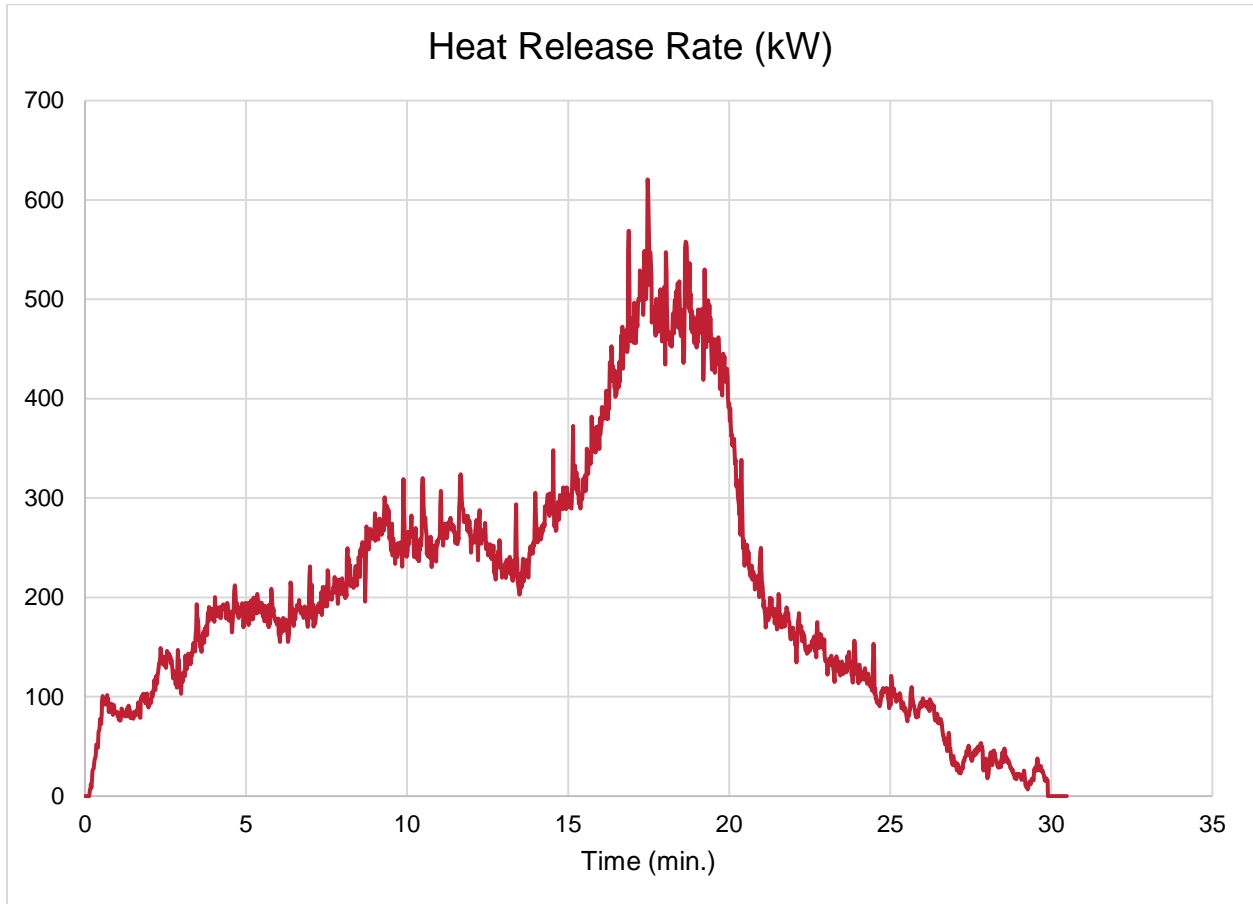
Figure 72 - Test 1 Wood Composite Siding/Asphalt Paper (75 kW) Heat Release Rate Plot

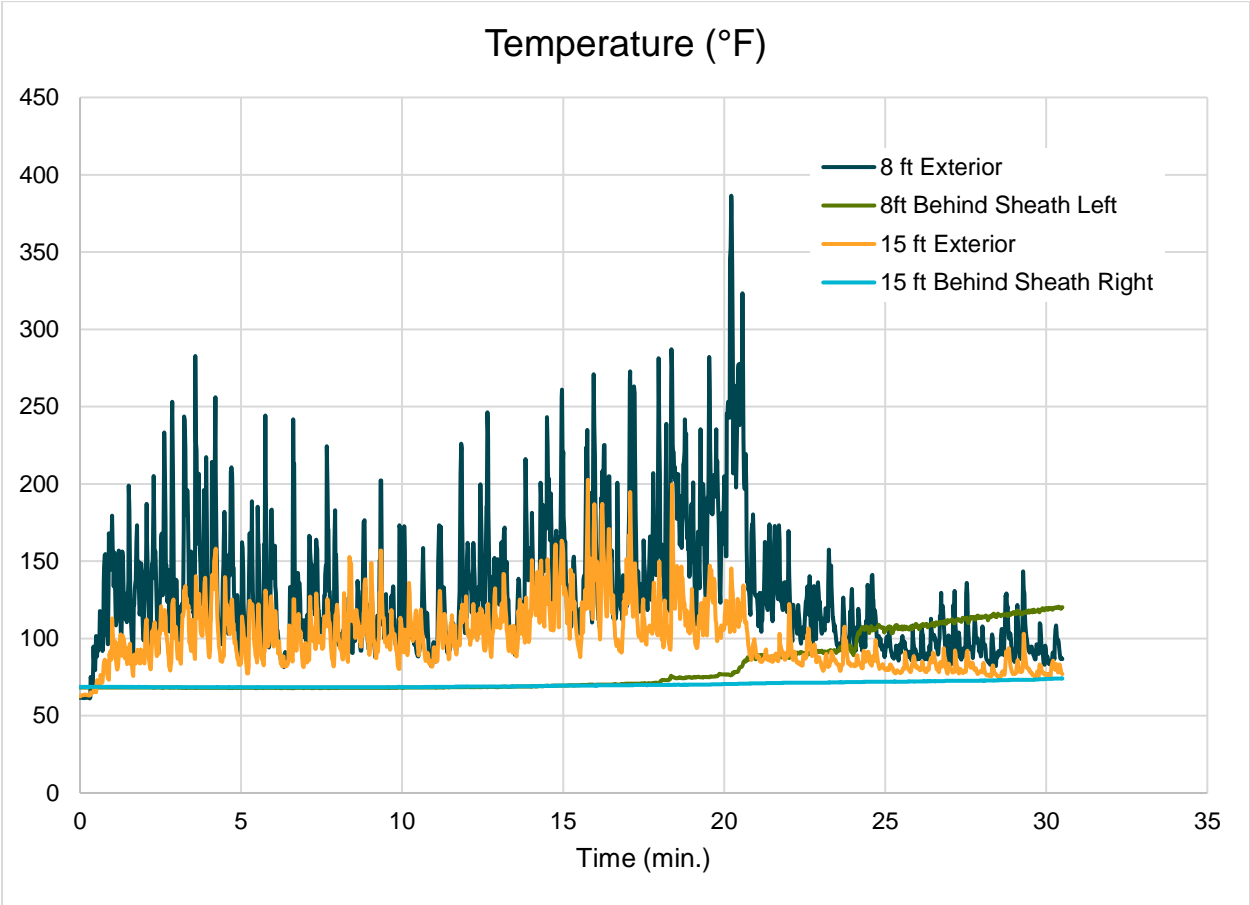
Figure 84 - Test 1 Wood Composite Siding/Asphalt Paper (75 kW) Temperature Plots (English Units)

Note: 8 ft Behind Sheath Right and 15 ft Behind Sheath Left channels were not functioning.

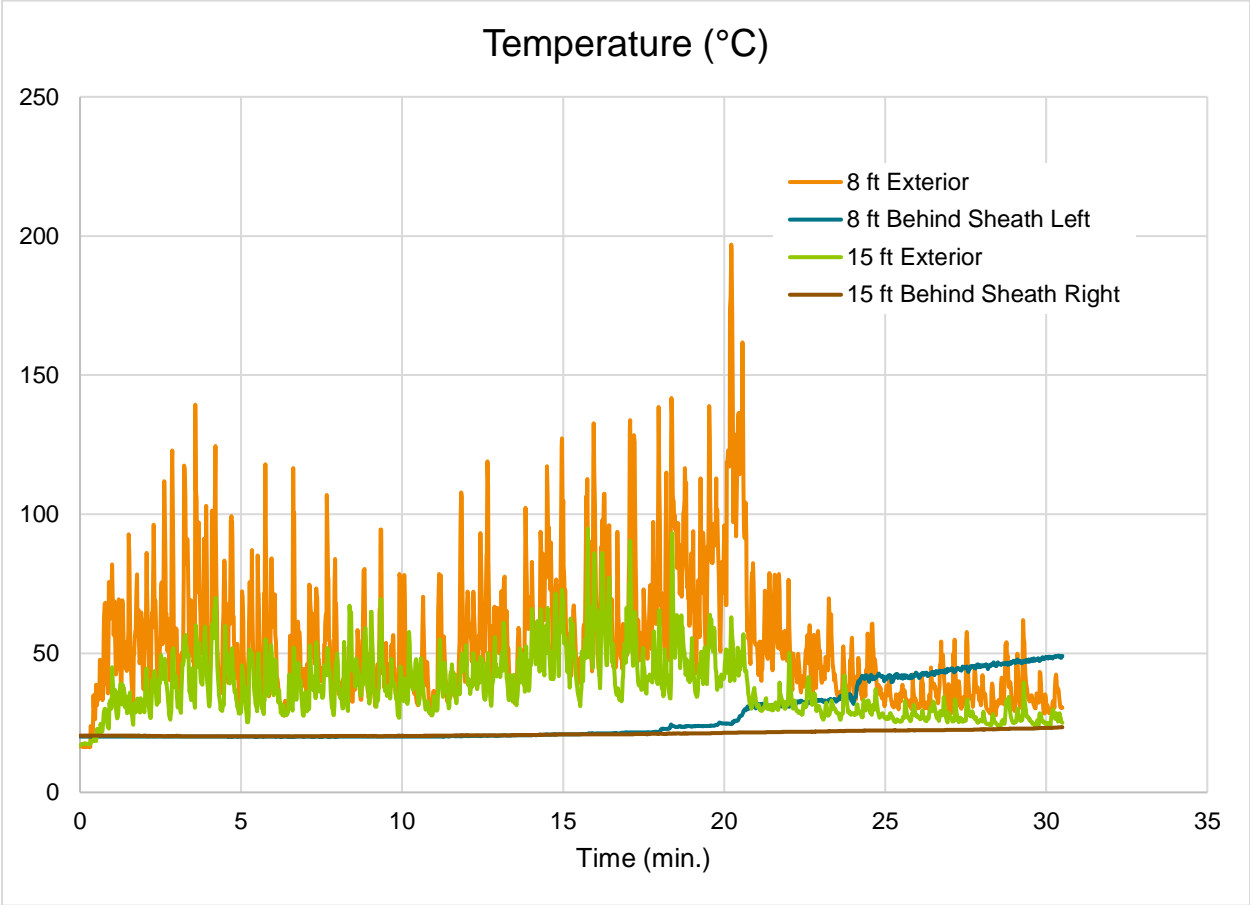
Figure 96 - Test 1 Wood Composite Siding/Asphalt Paper (75 kW) Temperature Plot (Metric Units)

Note: 8 ft Behind Sheath Right and 15 ft Behind Sheath Left channels were not functioning.

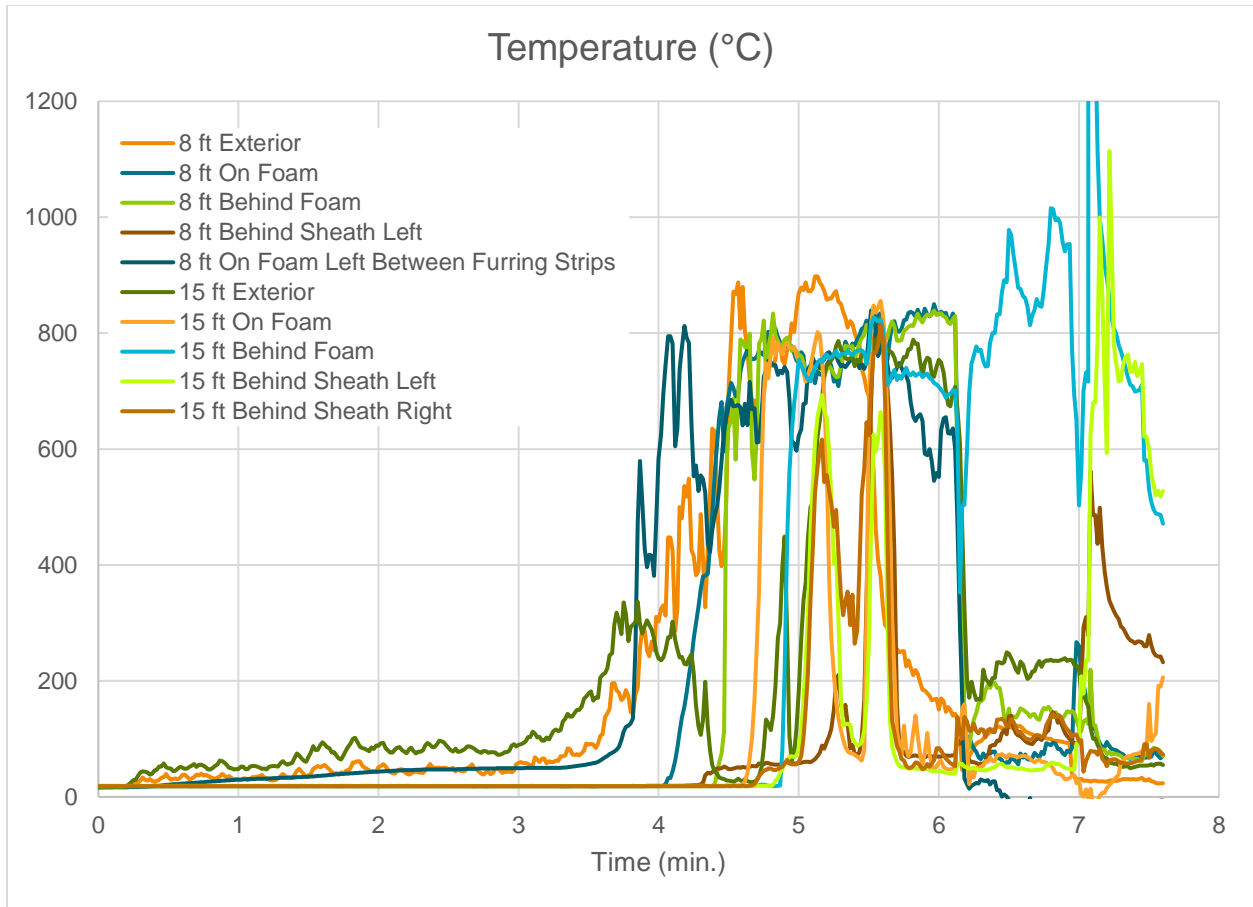
Figure 104 - Test 8 Vinyl Siding/Furring Strips with XPS/XPS Temperature Plot (Metric Units)

Note: 8 ft Behind Sheath Right channel was not functioning.
