IAFF SAFETY ADVISORY

RESPONDING TO RESIDENTIAL ENERGY STORAGE SYSTEMS • FEBRUARY 2025

This safety advisory is a summary of the UL Fire Safety Research Institute report: [“Considerations for Fire Service Response to Residential Battery Energy Storage System Incidents.”](#)

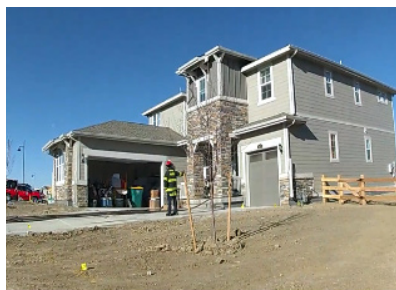
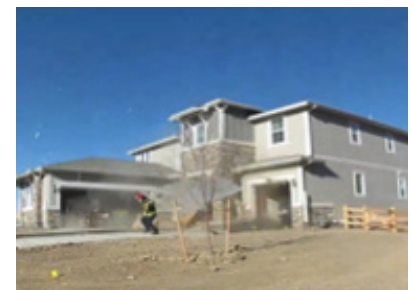
The explosion incident in Erie, CO, as described in Section 2 of the report, is an example that a significant explosion hazard can develop and even occur without any prior exterior indicators. At that incident, it was known that the garage was filled with smoke, but due to the visual similarity between ordinary smoke and unburned battery gas, the explosion hazard was not recognized. When the explosion occurred, the garage door was thrown from its opening and contacted the helmet of the incident commander as it traveled down the driveway. Given the condition of the garage at the time of arrival, hazard could also occur during size-up with no prior indication.

Pictures captured seconds prior to the deflagration. No exterior indicator of failure.

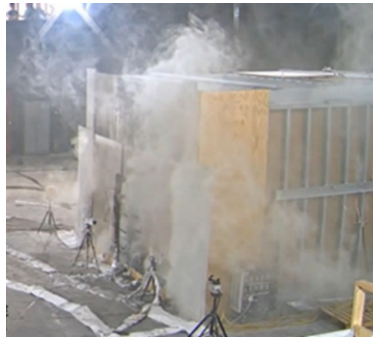
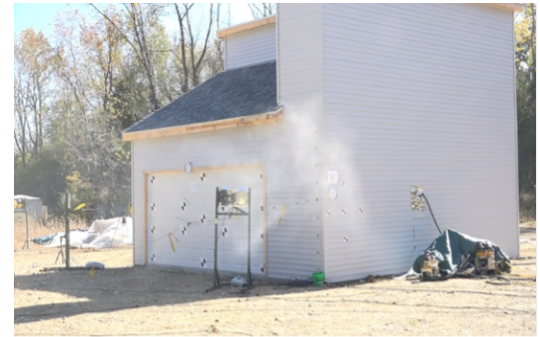
White/gray gas and vapor was first observed leaking out from around the garage door after it had first accumulated inside the structure for several minutes of thermal runaway propagation in Test 2. White/gray gases and/or vapors are only produced from the batteries when they experienced thermal runaways without burning, so continued leakage of these from a structure may indicate ongoing thermal runaways and that the batteries have not yet ignited. It is critical to recognize that this smoke appearance and related potential deflagration hazard is contrary to previous size-up guidance that implies “lazy” or non-turbulent white smoke is an incipient fire and does not cover this potential deflagration risk.

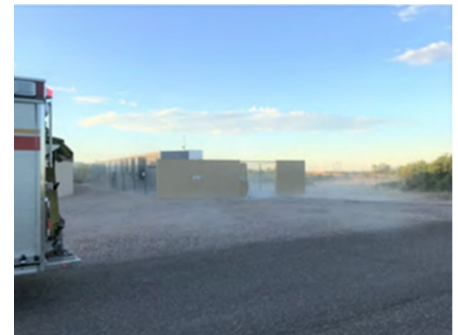
It should be considered that environmental conditions such as wind velocity and direction, terrain, and lighting conditions may impair the ability to identify the distinct battery thermal runaway effluent. Structural factors include the tightness of the seal around the garage door and any penetrations through the exterior walls. The figures below show an example of the conditions observed in Test 2, in outdoor UL experiment in 2020, and at the scene of the explosion in Surprise, AZ.

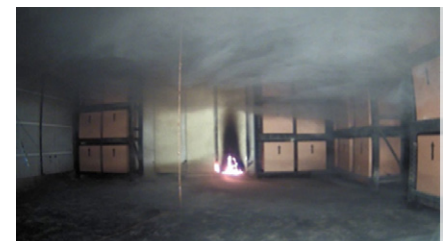
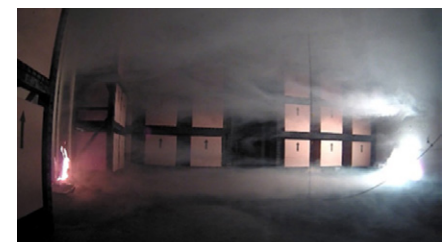
The components of battery gas stratify near the ceiling and the floor in a room where batteries are experiencing propagating thermal runaways. This tends to leave a characteristic visible region between a smoky layer at the floor and a smoky layer at the ceiling. As thermal runaways do not release as much thermal energy as a flaming fire, there is not as much thermally driven gas movement. As such, the gases may appear stagnant or slow-moving. This distinctive two-layer accumulation of lighter gases near the ceiling and heavier gases and vapors along the floor was clearly present in Test 2. It is important to recognize that this can represent an immediate flash fire or deflagration hazard.

Test 4 demonstrated that even after a transition to flaming (including a possible deflagration), the layer of battery gas near the floor may still be

recognizable and unique to a post-thermal runaway condition. Figure 186 provides two different viewing angles from Test 4 demonstrating this phenomenon.

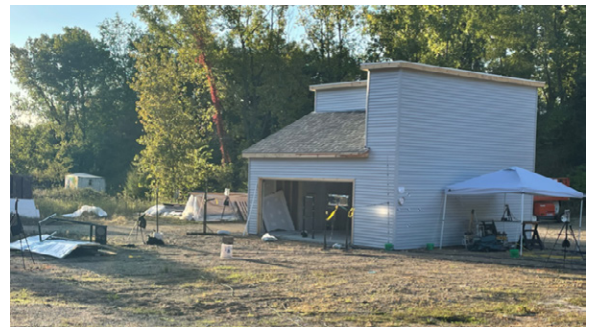
As observed by the forceful gas ejection and garage door damage in Test 2, a deflagration of accumulated battery gas can risk harm to fire fighters in the driveway or other potential vent locations, including windows or doors. The peak pressure is not known for Test 2, but a partial volume deflagration involving approximately 2% (or 0.4 kWh) of the cells in the initiating ESS unit in Test 4 demonstrated that a small volume of battery gas (~213 L) can generate pressures high enough (1–4 kPa) to shatter windows.

Notice the location of the door after the deflagration.

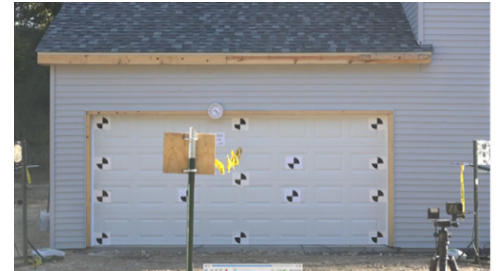
The deflagration event in Tests 2 occurred after a vapor cloud had started to form on the exterior of the garage, and exterior portable gas meters measured flammable gas concentrations higher than zero.
