STATE OF NEVADA  
TRAFFIC ACCIDENT REPORT

L-2003-010022-I

US 95/Rainbow Interchange Ramp #1 Beat LA 10 Urban

NEVADA HIGHWAY PATROL  
ACCIDENT SUPPLEMENT  
DIAGRAM

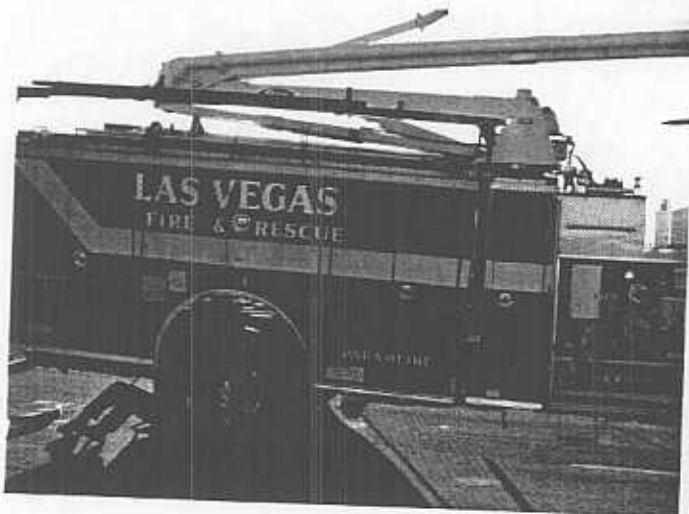
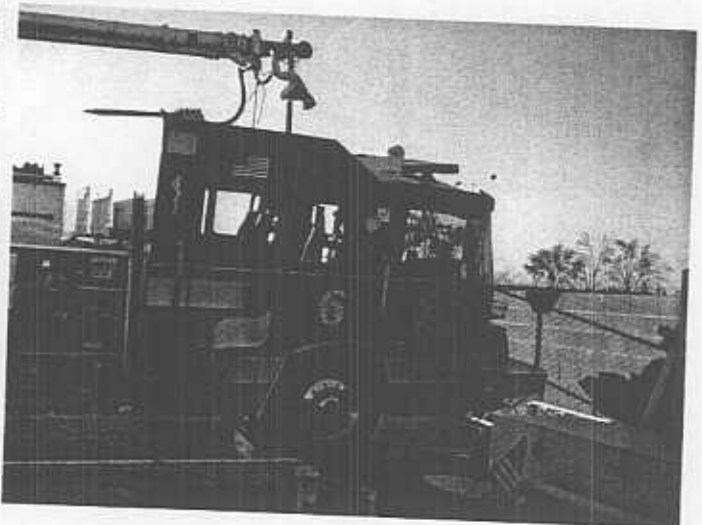
Right side damage: The right side was undamaged.

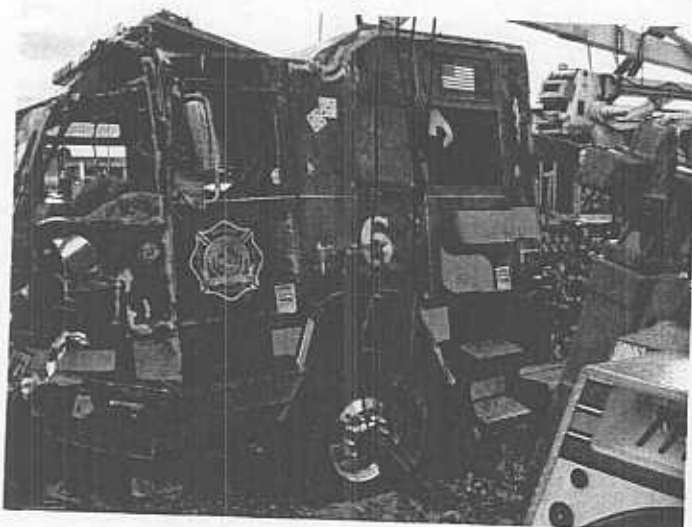
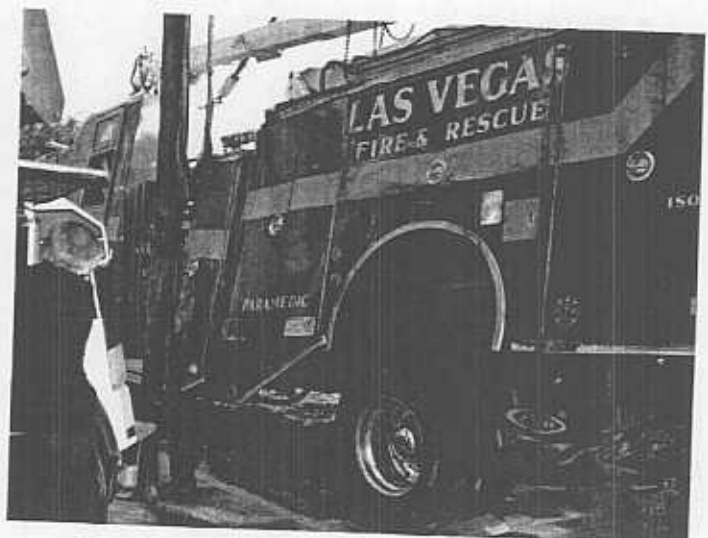
Left side damage: The body (front cab & rear body) of V-1 was separated from its frame and sat higher on the left side. There were scratches, scrapes and small dents across the entire left side. The fore auxiliary oxygen bottle storage door was detached and missing.

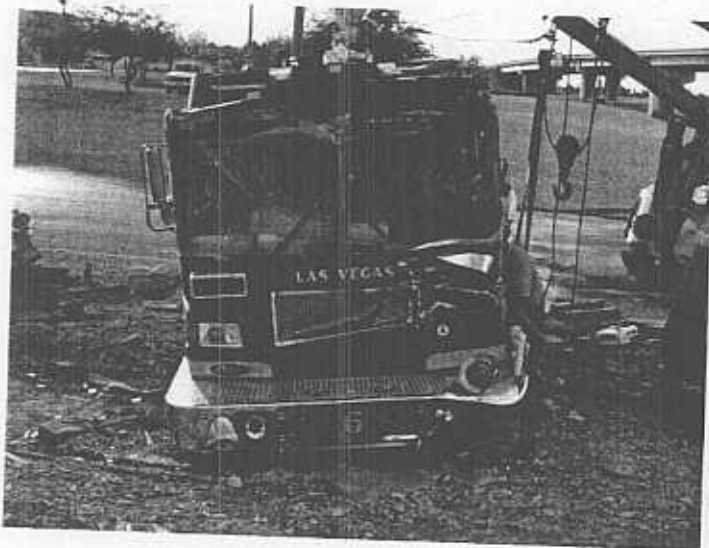
Front damage: The left front was pushed inward and rearward. The left front of the bumper was twisted downward. The left side of the grill was pushed inward. The assembly housing the left emergency strobe lights was pushed inward on its right side. The siren, which is mounted on top of the bumper on the left side, was pushed toward the right.
