Case Study E
Tallahassee, Florida
March 24, 2005

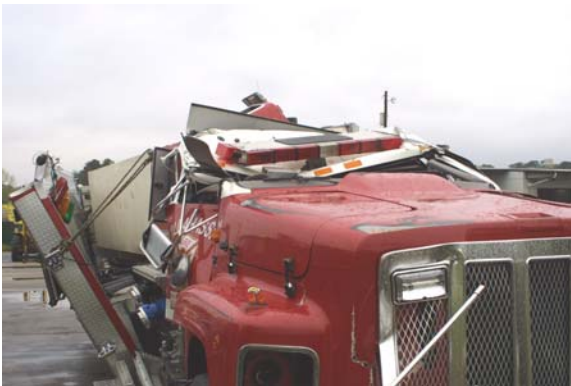
Figure E.1

In order to avoid striking the ambulance Tanker 13 swerved left across the centerline of the road. Upon taking this action the tanker driver noticed a civilian vehicle on the northbound (opposite) shoulder that had stopped for the approaching fire apparatus. To avoid striking the civilian vehicle the tanker driver steered the vehicle back towards the right, causing the tanker to roll over. As the tanker rolled and slid it struck the rear of the stopped civilian vehicle before coming to a rest (**Figure E.1**).

1. Fire apparatus traveling together to an emergency incident should maintain a safe following distance between the vehicles. Most sources, including NFPA, IFSTA, and the United States Fire Administration recommend that emergency vehicles traveling together maintain a distance of 300 to 500 feet between the vehicles. This reduces the chance of emergency vehicles running into each other and also allows room for evasive maneuvers should a civilian vehicle pull back into the lane of travel after being passed by the first emergency vehicle.

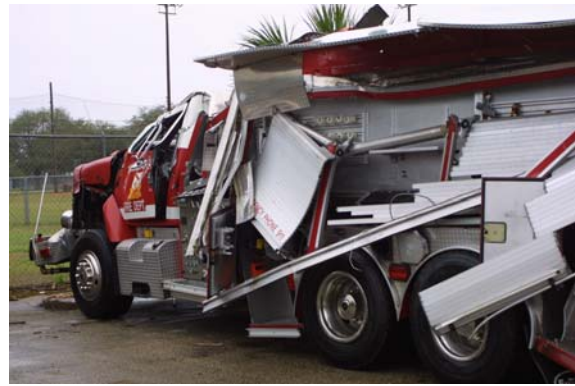
Figure E.2

The driver of Tanker 13 was trapped in the vehicle and required extrication. He received minor injuries and was treated and released from the hospital. The civilian driver was uninjured. The fire apparatus was totally destroyed (**Figure E.2**).

3. Wearing a seatbelt can prevent serious injuries when the apparatus is involved in a collision. In this incident the driver of Tanker 13 was wearing his seatbelt. Despite the fact that the apparatus rolled one complete revolution and was totally destroyed, the driver received minor injuries that did not require hospitalization.
