Case Study F Toledo, Ohio March 10, 2005

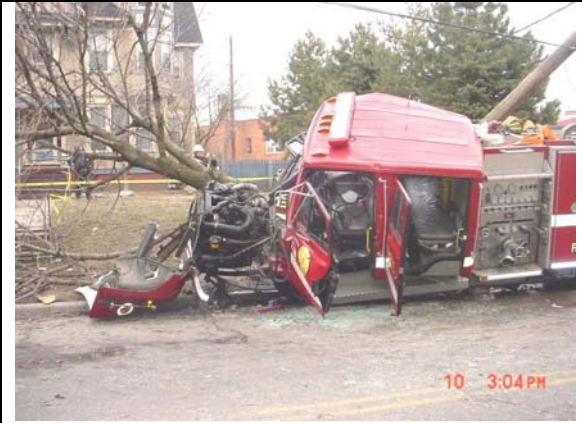
Figure F.1

Two civilian vehicles that were also traveling westbound pulled over to the shoulder as the fire vehicles approached. After the rescue vehicle passed, one of the civilian vehicles failed to note Engine 7 approaching and pulled back into the lane of traffic. Engine 7 was unable to take evasive actions in time to prevent a collision. It was reported that following the collision, Engine 7's steering and braking systems were rendered inoperative and there was little the driver/operator could do to control the vehicle. The careening engine missed several other vehicles and then came to a rest after striking a utility pole and a tree (**Figure 1**).

1. Fire apparatus traveling together to an emergency incident should maintain a safe following distance between the vehicles. Most sources, including NFPA, IFSTA, and the United States Fire Administration recommend that emergency vehicles traveling together maintain a distance of 300 to 500 feet between the vehicles. This reduces the chance of emergency vehicles running into each other and also allows room for evasive maneuvers should a civilian vehicle pull back into the lane of travel after being passed by the first emergency vehicle.

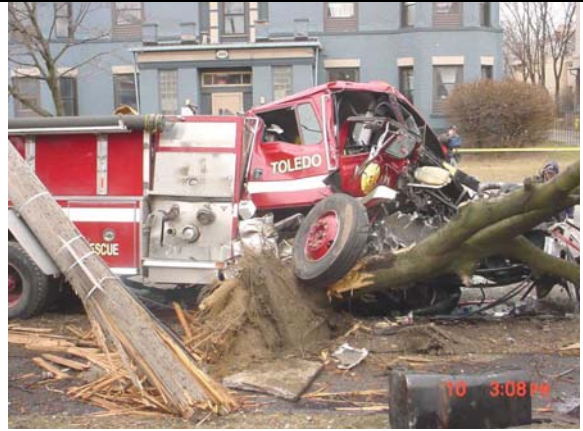
Figure F.2

All four of the fire fighters on Engine 7 were transported to the hospital. Two were admitted with non-life threatening injuries and two were treated and released. The driver of the car also received minor injuries. The civilian driver, who had a long history of traffic violations and license suspensions, was cited for failure to yield right-of-way to an emergency vehicle. The fire apparatus was completely destroyed (**Figure 2**).

2. Wearing a seatbelt can prevent serious injuries when the apparatus is involved in a collision. In this incident the fire fighters on Engine 7 were wearing their seatbelts. Despite the fact that the apparatus struck a car, a utility pole, and tree and was totally destroyed, the fire fighters all received minor injuries.
